Accelerated Fresh Water Corrosion Study & Remediation of Steel Structures

Chad W. Scott, P.E.¹, Gene Clark, P.E.², and Joe Radniecki³

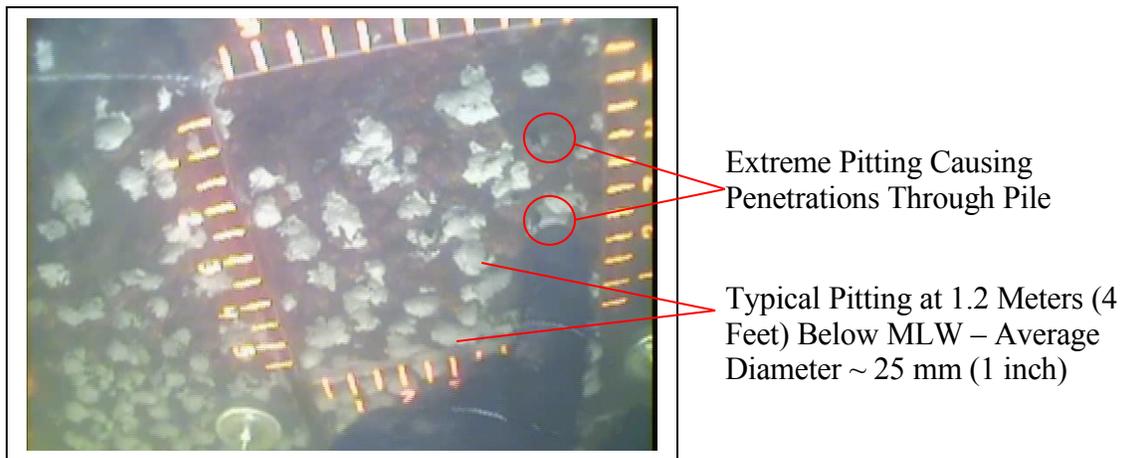
At 22 sites located around the DSH, divers made visual inspections and took pile thickness readings. Similar corrosion rates and pitting were found throughout the sites on structures of similar age. In general, corrosion and pitting was greatest in the areas 0.3 to 3 meters (0.5 to 10 ft) below the DSH Mean Low Water (MLW) level, with the most severe around the 1.2 meter (4 ft) depth. On piling older than 35 years, pitting was significant and perforations through structural members were found. Figure 1 shows an example of pitting and penetrations found at the 1.2 meter (4 ft) depth. Table 1 shows a qualitative summary of the corrosion and pitting levels.

Figure 1. Typical Sheet Pile Pitting and Penetrations
Table 1. Corrosion Rate and Pitting Summary

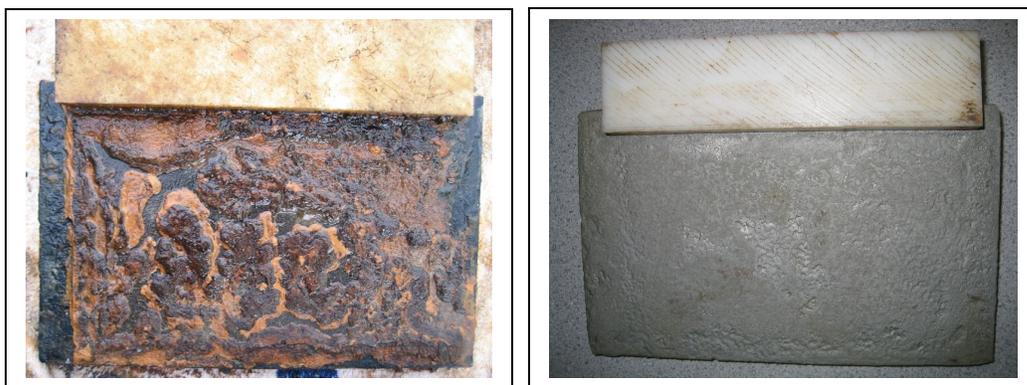
Figure 2. Uncoated Test Coupon Before and After Cleaning

Results of the testing to date show uniform corrosion rates between 0.043 mm to 0.095 mm (1.7 to 3.7 mils) loss per year which is consistent with both the long term

degradation rates and the measurements recorded in the 2006 LPR study. It is important to note that *average* thickness of unprotected steel structures will deteriorate at these values, but *pitting rates* will be approximately 7.5 times higher. These higher pitting rates need to be taken into consideration when estimating the expected useful life of unprotected steel.

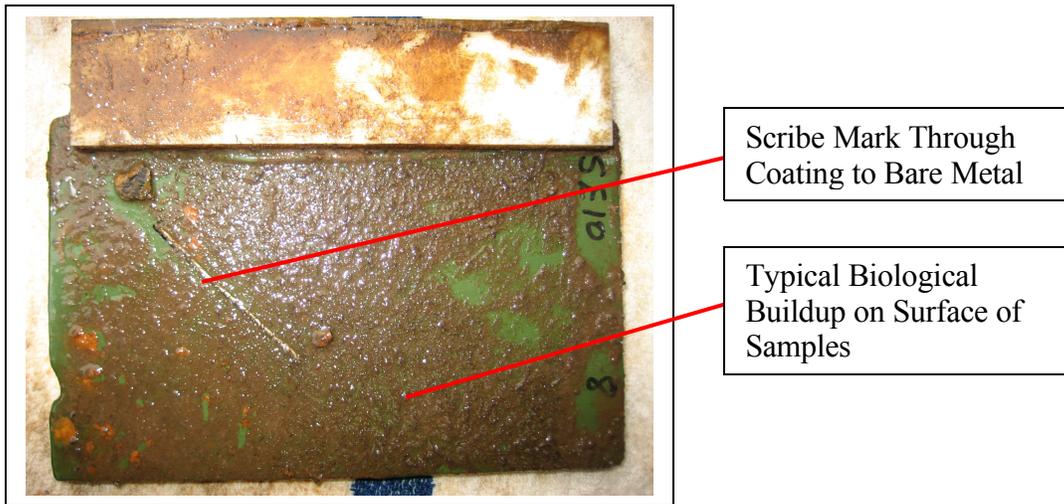
In the fall of 2008, representative coupons were removed from all of the test sites installed in 2006 and 2007 and inspected. Visual observations were documented on all samples, and some coupons were analyzed for corrosion loss and biological growth testing. Coated samples were inspected and all showed no signs of loss of adhesion anywhere including near the etched areas. A typical coated test sample removed for inspection is shown in Figure 3.

Figure 3. Coated Test Coupon

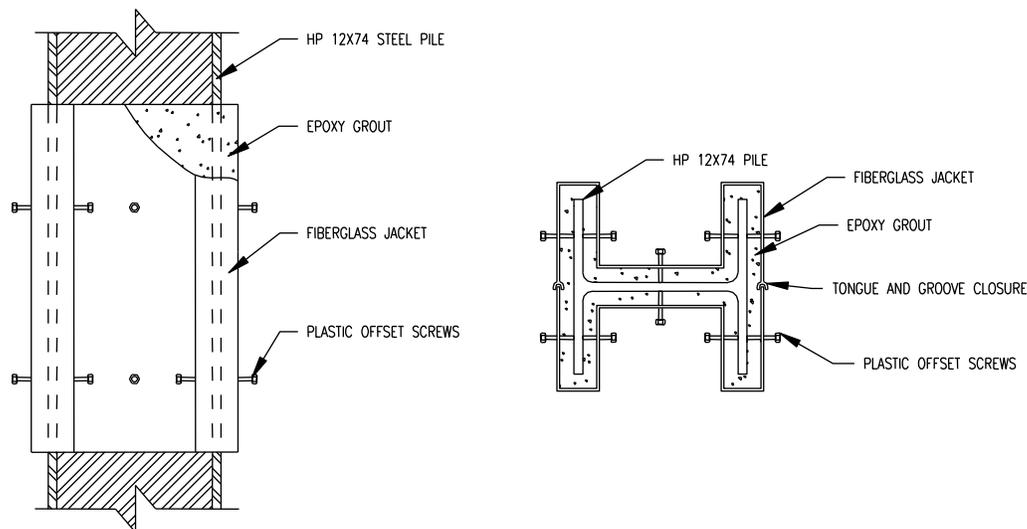
Figure 6. H-Shaped Fiberglass Protective System

The first system is comprised of an H shaped fiberglass jacket installed around an existing steel H-Pile after removing marine growth and corrosion. The jacket is fabricated in two halves which are held together by tongue and groove closures. Dimensions of the fiberglass jacket were customized to create a 25 mm (1 in) void between it and the steel. The bottom of this void is sealed, and an epoxy grout is pumped into the space, forming bonds with the steel and fiberglass and preventing further corrosion. A depiction of H shape fiberglass system is shown in Figure 6.

This system also has an added advantage as it provides some structural benefits in addition to corrosion protection. Cost for installation materials for this system is approximately \$615 per meter (\$190 per ft); installation labor will vary by site.

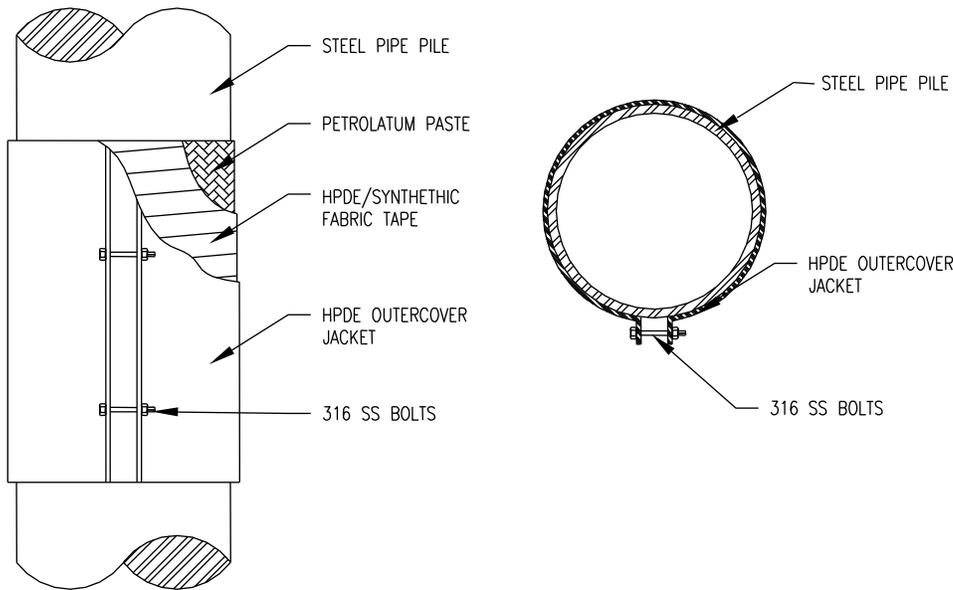
Figure 7. HPDE Pipe Pile Protective System

The final system installed to date is designed to protect cylindrical steel pipe pile. The outer jacket cover of this system is fabricated from high density polyethylene (HDPE). After cleaning the pile, petrolatum paste is used to fill any large pits on the steel surface. The paste is water displacing and contains corrosion inhibiting and biocide additives and creates a seal to prevent direct contact between water and steel and resulting corrosion.

An HPDE and synthetic fabric tape is then wrapped around the paste, providing an additional barrier to water penetration. Finally the HPDE jacket is installed around the other components and joined together with 316 stainless steel bolts which are tightened to force out any water and air and protect the inner corrosion inhibiting components from damage by external forces. Installation materials for this system are approximately \$265 per meter (\$80 per ft). A depiction of the HPDE pipe pile system is shown in Figure 7.

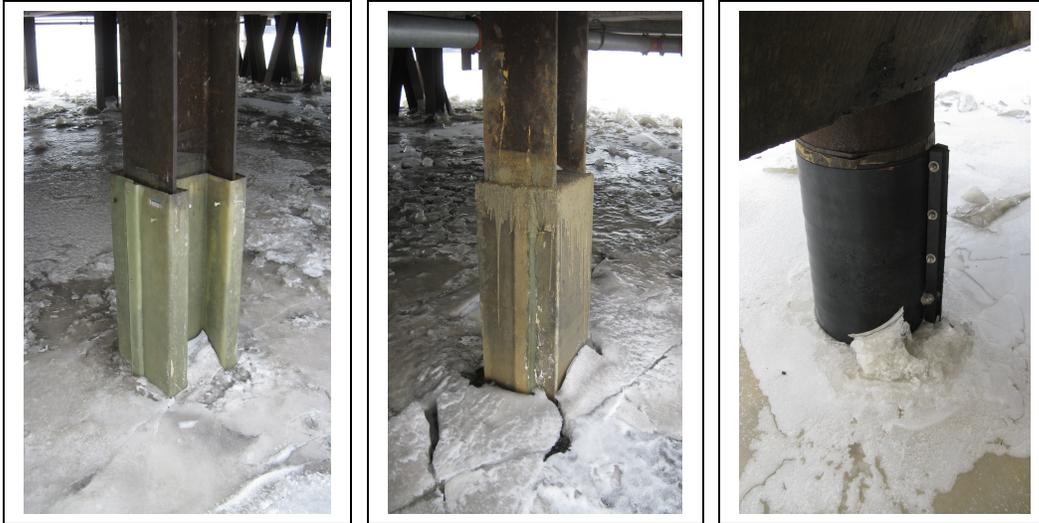
Figure 8. H-Shaped, Rectangular, and Pipe Pile Protective Systems

The project study team will continue with systematic yearly observations of each system's ability to withstand ice impact and abrasion forces and publish results for use by harbor and other cold region port facility owners and managers. A photo of each alternative repair installation is shown in Figure 7.
