# Cofferdam Applied Coating Trial

Prepared for the City of Superior, Wisconsin

## Cofferdam Applied Coating Trial AMI Project 081127

Prepared for the City of Superior, Wisconsin  
October 20, 2009

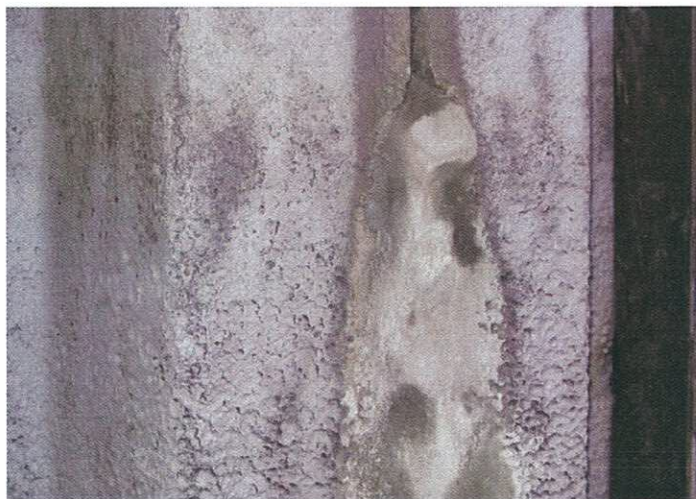
Picture 2: Hydraulic cement sealing an interlock, some damp spots are visible.

On interlocks with active water flow after the application of hydraulic cement, thin steel bars or angle were welded over the interlocks. Water leaking through the

interlocks was channeled down the gap created by welded steel and discharged below the line where the coatings were applied. This left the surrounding wall dry and provided a surface at the interlocks that could be coated.

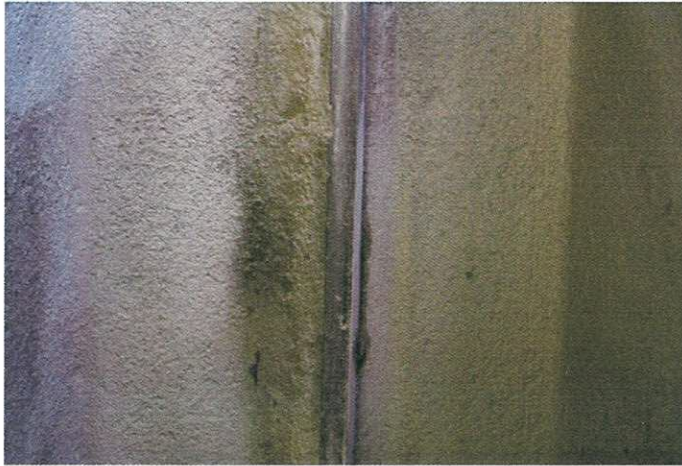
**Picture 3: Angle iron used to seal an interlock.**

The areas where the water could not be fully stopped may be susceptible to premature failure of the coating. These areas were marked on sketches of the wall surface and photographs were taken that covered all areas of the wall before a coating was applied. This documentation will allow us to determine if coating failures found in future inspections may have been due to imperfect application conditions.

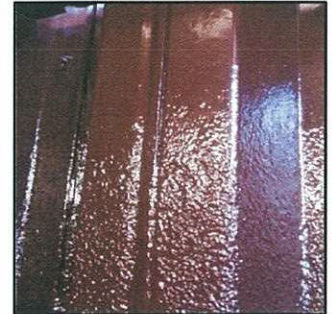
### Ceilcote Interzone 954

Interzone 954 is a high solid modified epoxy that is supplied in two parts. The parts were mixed 4 to 1 in a standard paint pail with a drill mounted mixer and then sprayed on using a standard airless spray system. Two passes were needed to get the recommended wet film thickness of 25 mils. The coating sprayed easily and there were no issues with the equipment during this application. The product set quickly and can be immersed in water in as little as 15 minutes after application.

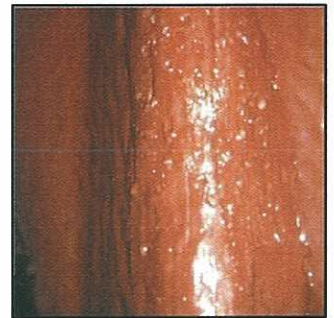
### AquaPure HR

AquaPure HR is a modified epoxy based coating. It was applied using the Graco Xtreme Mix rig. The coating sprayed nicely but a malfunction with the spray equipment led to considerable delays during the application. The coating was sprayed to an average dry film thickness of 24 mils in two passes. The application took 25 minutes and the coating was allowed to cure 4 hours before re-immersion.

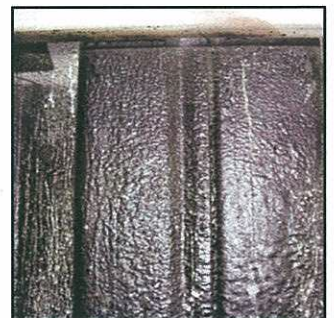
### Ecologiq E-shield

Ecologiq E-shield is an elastomeric membrane that is available with anti-fouling agents specifically designed to decrease the amount of zebra mussels that attach to the surface. This product is unique in that it is designed to remain very flexible. The two component coating was applied using a relatively simple arrangement of two piston pumps driven off of a single motor each with separate lines leading to a custom spray gun. This coating sprayed to 54 mils in 45 minutes and cured for 18 hours before re-immersion.

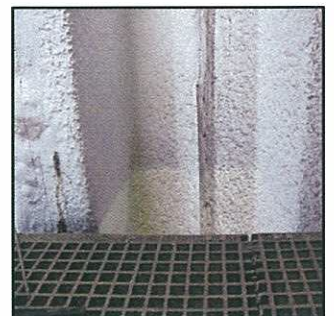
### Biocoatings Marine Vinyl Coating

Biocoating supplied a marine vinyl coating for this test. This product is a solvent based, VOC free product. The application of this product went very well and it can be applied with either an air or airless sprayer. The product dried within seconds allowing for multiple passes in a short amount of time. Three passes were used to deliver a 9.1 mil average coating thickness in 30 minutes. A cure time of 15 hours before re-immersion was specified for this product.

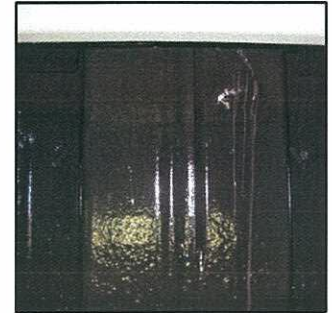
### Thiokol LPE 5100

Thiokol is a high solids high build type epoxy coating. It was sprayed on in one coat to an average dry film thickness of 46 mils. The Graco Xtreme Mix pump was used and the whole application took about 12 minutes. There were no equipment or other issues while applying this coating. The coating produced a hard dry surface within ten minutes and could be re-immersed within 15 minutes.

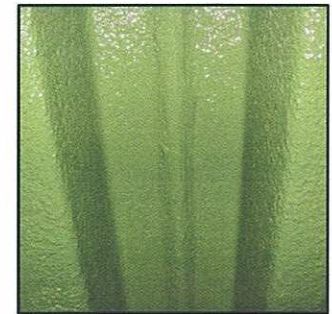
### Acotec Humidur

Humidur is a solvent free modified epoxy based coating. It was applied using the Graco Xtreme Mix pump. Prior to being sprayed on some of the coating was mixed and applied manually over the interlocks and areas requiring extra protection. The material sprayed well but there was a malfunction of spray equipment during the application. The final dry film thickness of the test sample was 31 mils. The application of the Humidur took 30 minutes not counting the time for the sprayer malfunction. The coating was left to cure for one hour before re-immersion.

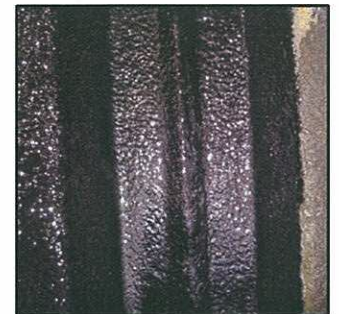
### Sherwin Williams Envirolastic AR200HD

Envirolastic AR200HD Polyurea is a two part system designed for abrasion and tear resistance. The coating was applied with the Graco Reactor Pump. The coating sets up almost instantly, allowing the coating to reach an average dry film thickness of 140 mils in three passes of about 30 to 40 mils. The application of this coating took 45 minutes and the product can be re-immersed in 1-2 hours.

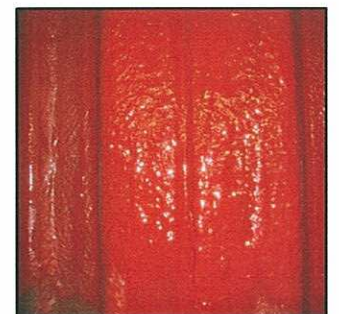
### Versaflex FSS50DM

This coating is very similar to the Envirolastic AR200HD from Sherwin Williams, although the bright orange color of the Versaflex product made the application in the limited light environment of the cofferdam easier. The color also allowed the applicator to easily identify pinholes and holidays. The application went well other than a delay caused by an equipment malfunction resulting in only one of the two components being applied at the beginning of the application. The component needed to be cleared off the wall before the application could resume to prevent the coating from blistering.
