DSPA CORROSION INVESTIGATION REPORT

AMI #061016 DATE: JULY to DECEMBER, 2006

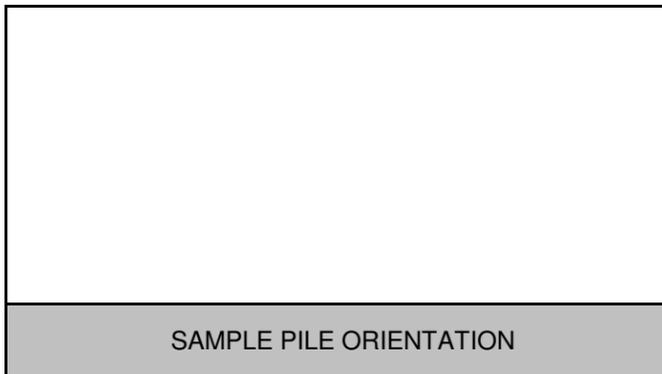
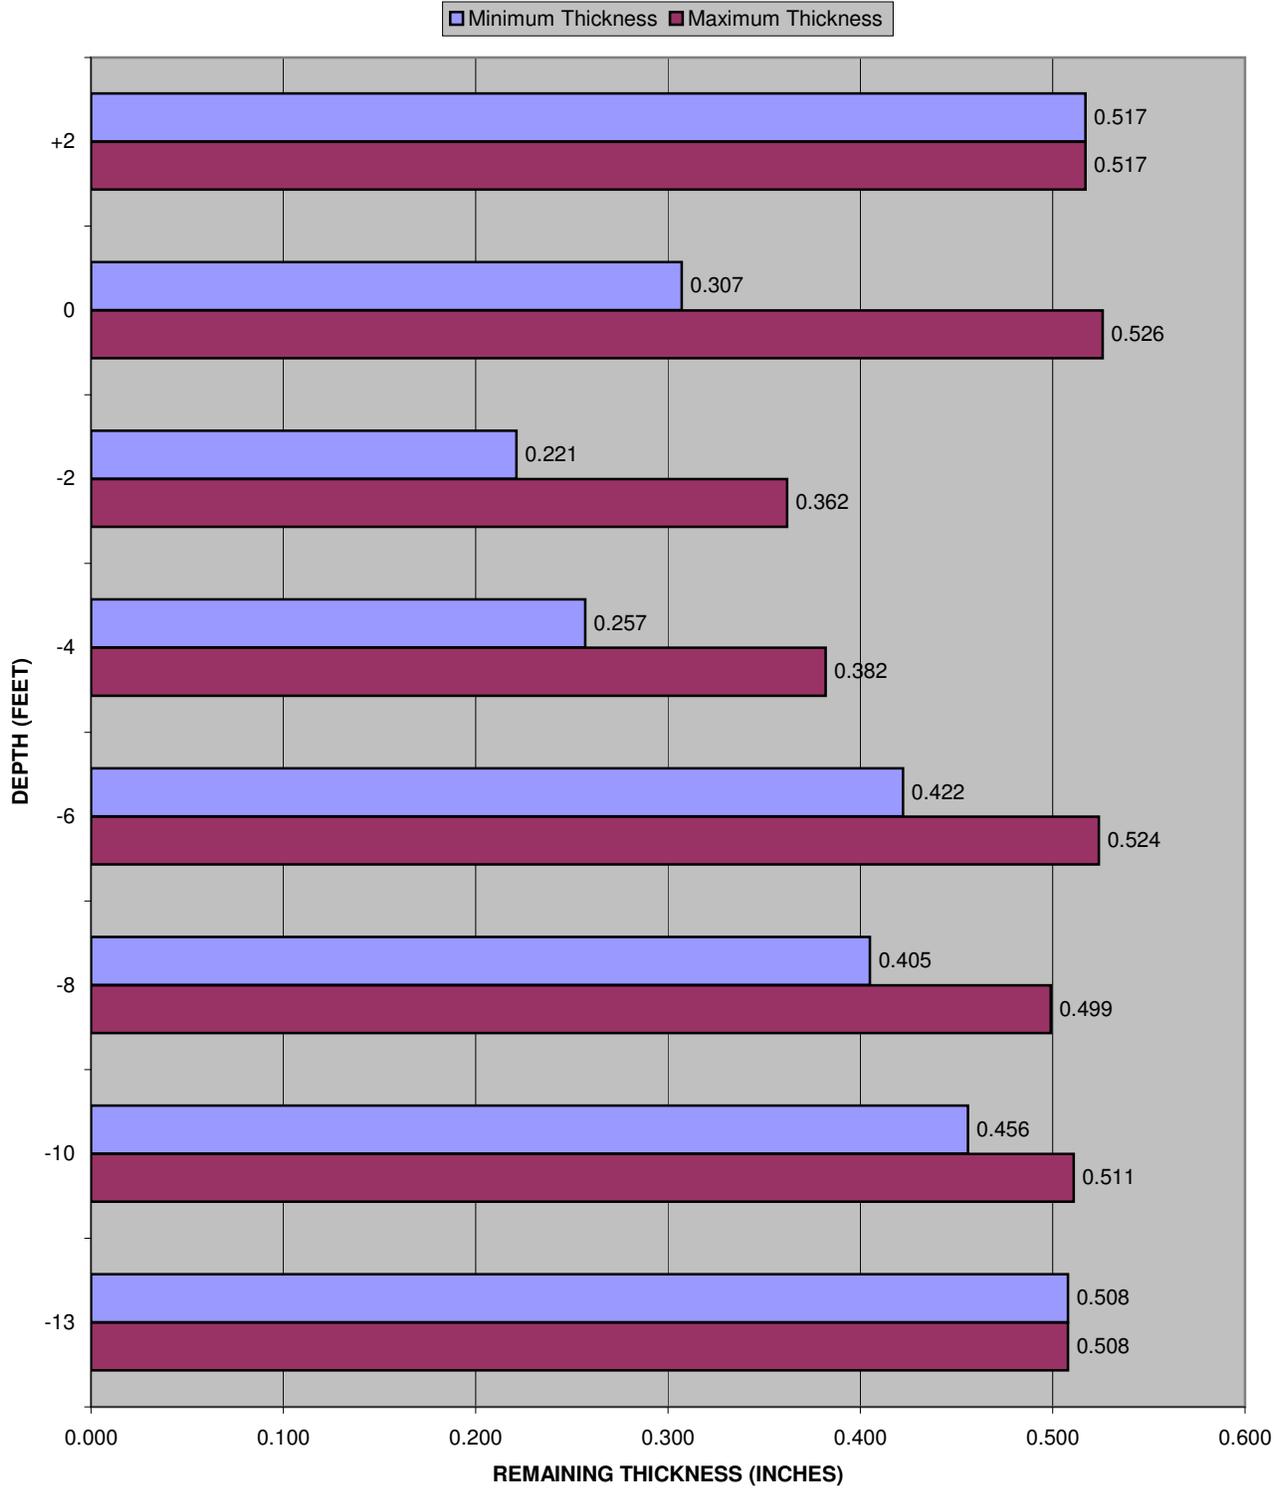
MINNESOTA SLIP- REMAINING STEEL
SITE I.D. # 5
(Measured Steel Thickness of 0.517 inches)

STATION	Depth (IGLD +/-)	Marine Growth				Protective Coating				Corrosion			Steel Max. Remaining Thickness	Pit Penetration Readings					Pit Diameter Readings					Comments			
		Present	Type	Thickness	Coverage	Present	Type	Thickness	Coverage	Present	Type	Concentration (High Mod. Low)		Pit Penetration Readings					Pit Diameter Readings								
														1	2	3	4	AVG	1	2	3	4	AVG				
1	+2												0.517													Storm sewer outfall by sample point	
2	0	x	White Coating	0.125	100%					x	Pit	Mod	0.526	0.125	0.250	0.188	0.313	0.219	0.500	0.750	0.625	0.625	0.625				
3	-2	x	orange nod / Algae	.25 to .75	75%					x	Pit	Mod	0.362	0.125	0.125	0.125	0.188	0.141	0.375	0.500	0.500	0.500	0.469			Orange Nodules- Larger & Softer	
4	-4	x	orange nod / Algae	.25 to .75	75%					x	Pit	Mod	0.382	0.094	0.125	0.125	0.156	0.125	0.125	0.250	0.250	0.250	0.250	0.219			Less Pitting on in Pan
5	-6	x	Mussels/ sponges	.5 to .75	75% 25%					x	Pit	Low	0.524	0.063	0.094	0.125	0.125	0.102	0.250	0.125	0.250	0.575	0.300			Sporadic Pitting

6	-8	x	Mussels/ sponges/O Nod	.5 to .75	70/20/10					x	Pit	Low	0.499	0.094	0.094	0.125	0.063	0.094	0.250	0.250	0.188	0.125	0.203			Etched surface / small pits	
7	-10	x	Orange Nod - Z mussels	.5 to .75	50% 50%					x	Uniform	Low	0.511	0.063	0.063	0.031	0.063	0.055	0.125	0.125	0.063	0.125	0.110			Etched surface / small pits	
8	-13	x	Orange Nod - Z mussels	.5 to .75	50% 50%								0.508					0.000						0.000		Mudline @13 ft, Soft Silty bottom / smooth steel	
9	-20																	0.000						0.000			
10	ML																	0.000						0.000

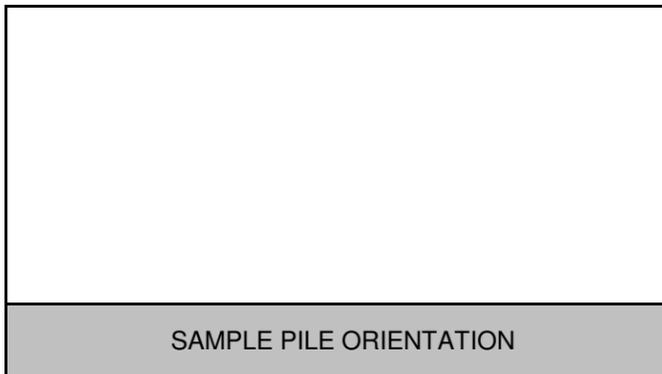
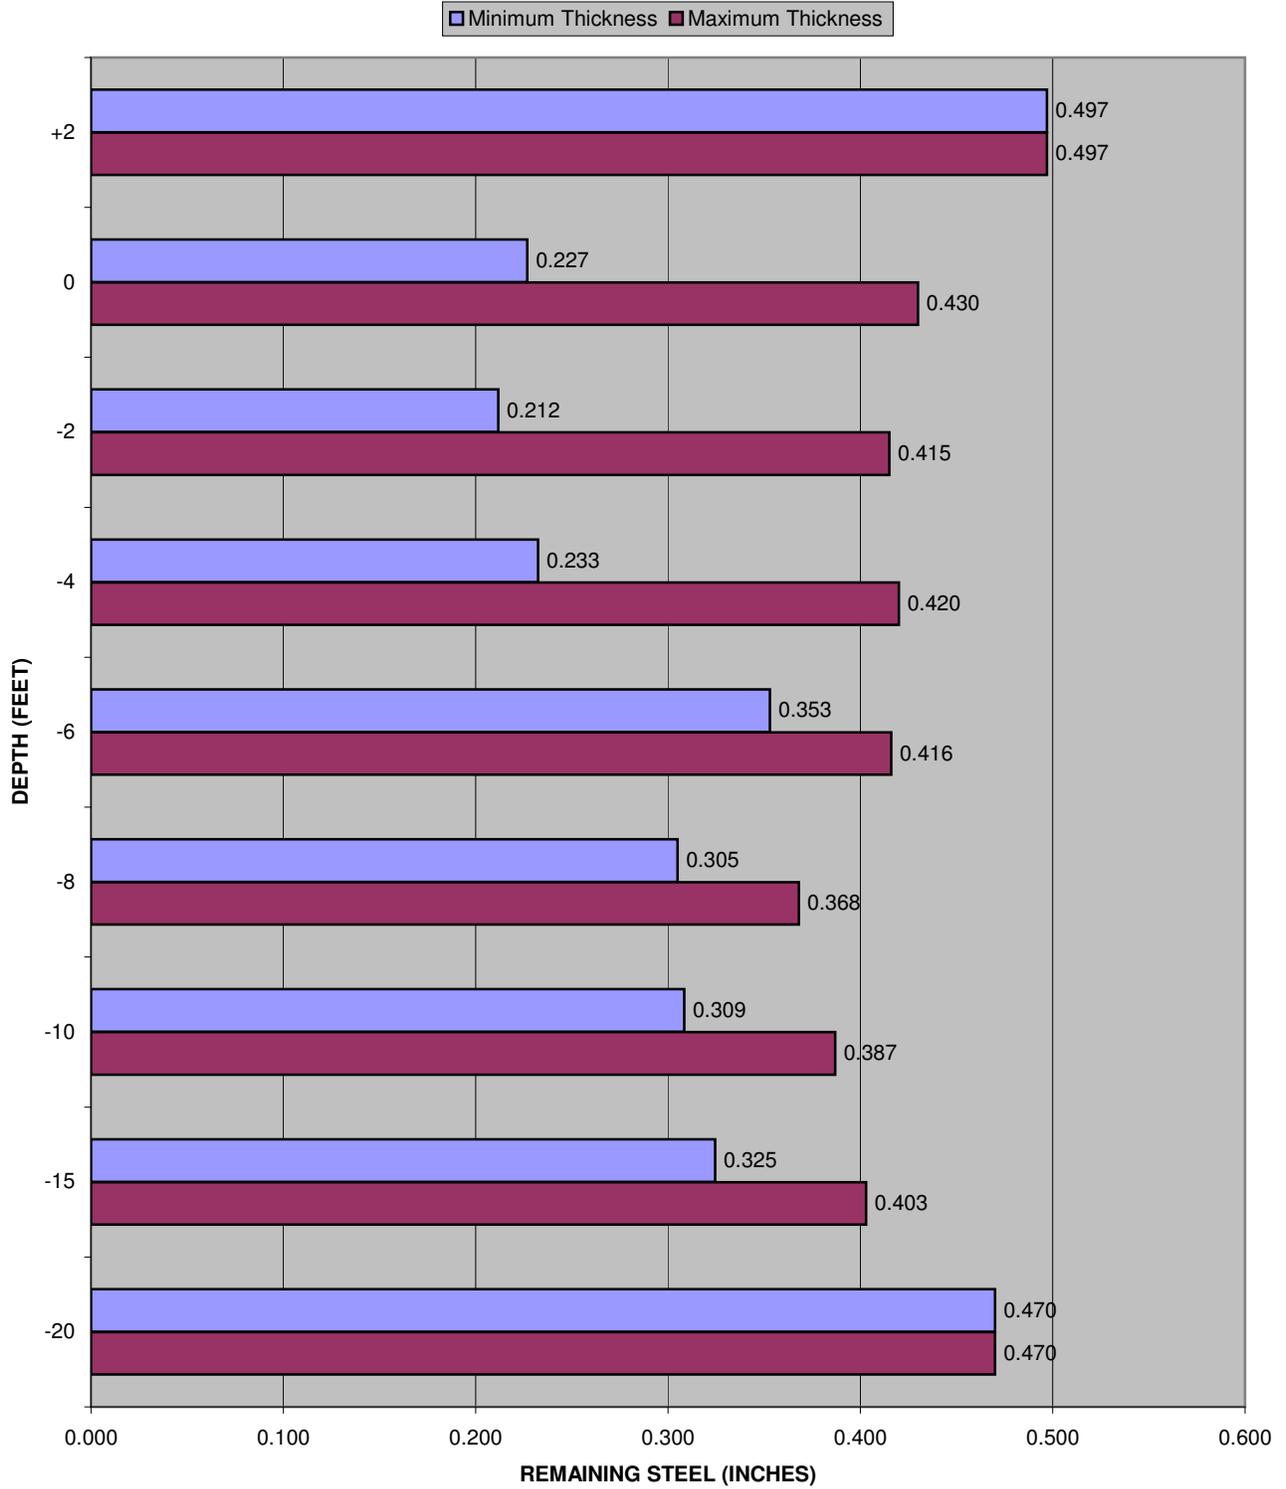
DECC DOCK- REMAINING STEEL
SITE I.D. # 6
(Measured Steel Thickness of 0.497 inches)

STATION	Depth (IGLD +/-)	Marine Growth				Protective Coating				Corrosion			Steel Max. Remaining Thickness	Pit Penetration Readings					Pit Diameter Readings					Comments	
		Present	Type	Thickness	Coverage	Present	Type	Thickness	Coverage	Present	Type	Concentration (High Mod. Low)		Pit Penetration Readings					Pit Diameter Readings						
														1	2	3	4	AVG	1	2	3	4	AVG		
1	+2					x	Coal / Tar	unk	unk				0.497												Present Above IGLD
2	0	x	Algae/orange nod / white	<.25	100%					x	Pit	High	0.430	0.125	0.250	0.188	0.250	0.203	0.500	0.750	0.500	0.750	0.625		Heavy Pits on both out & in pans
3	-2	x	Algae/ Mussels	.25 to 1.0	Sporadic					x	Pit	High	0.415	0.188	0.250	0.125	0.250	0.203	0.500	0.750	0.500	0.625	0.594		small pits within large pits
4	-4	x	Algae/mussels/s porges	.25 to 1.0	Sporadic					x	Pit	High	0.420	0.125	0.250	0.125	0.250	0.188	0.500	0.500	0.500	0.500	0.500		less pitting on in pans

5	-6	x	Algae/mussels/s porges	.25 to 1.0	Sporadic					x	Pit	Mod	0.416	0.063	0.063	0.063	0.063	0.063	0.188	0.250	0.250	0.125	0.203		pits on in &out pans similar
6	-8	x	Algae/mussels/s porges	.25 to 1.0	Sporadic					x	Pit	Mod	0.368	0.063	0.063	0.063	0.063	0.063	0.250	0.125	0.250	0.188	0.203		pits on in &out pans similar
7	-10	x	Less Algae more Mussels	1 to 1.5	80% 20%					x	Pit	Mod	0.387	0.063	0.063	0.094	0.094	0.079	0.188	0.125	0.188	0.250	0.188		pits on in &out pans similar
8	-15	x	Mussels	1 to 1.5	100%					x	Uniform	Low	0.403	0.094	0.063	0.000	0.000	0.079	0.500	0.250	0.000	0.000	0.375		Only 2 pits in sample area
9	-20	x	Mussels	1 to 1.5	100%					x	Uniform	Low	0.470					0.000					0.000		Etched surface / Mud line @ 20 ft
10	ML

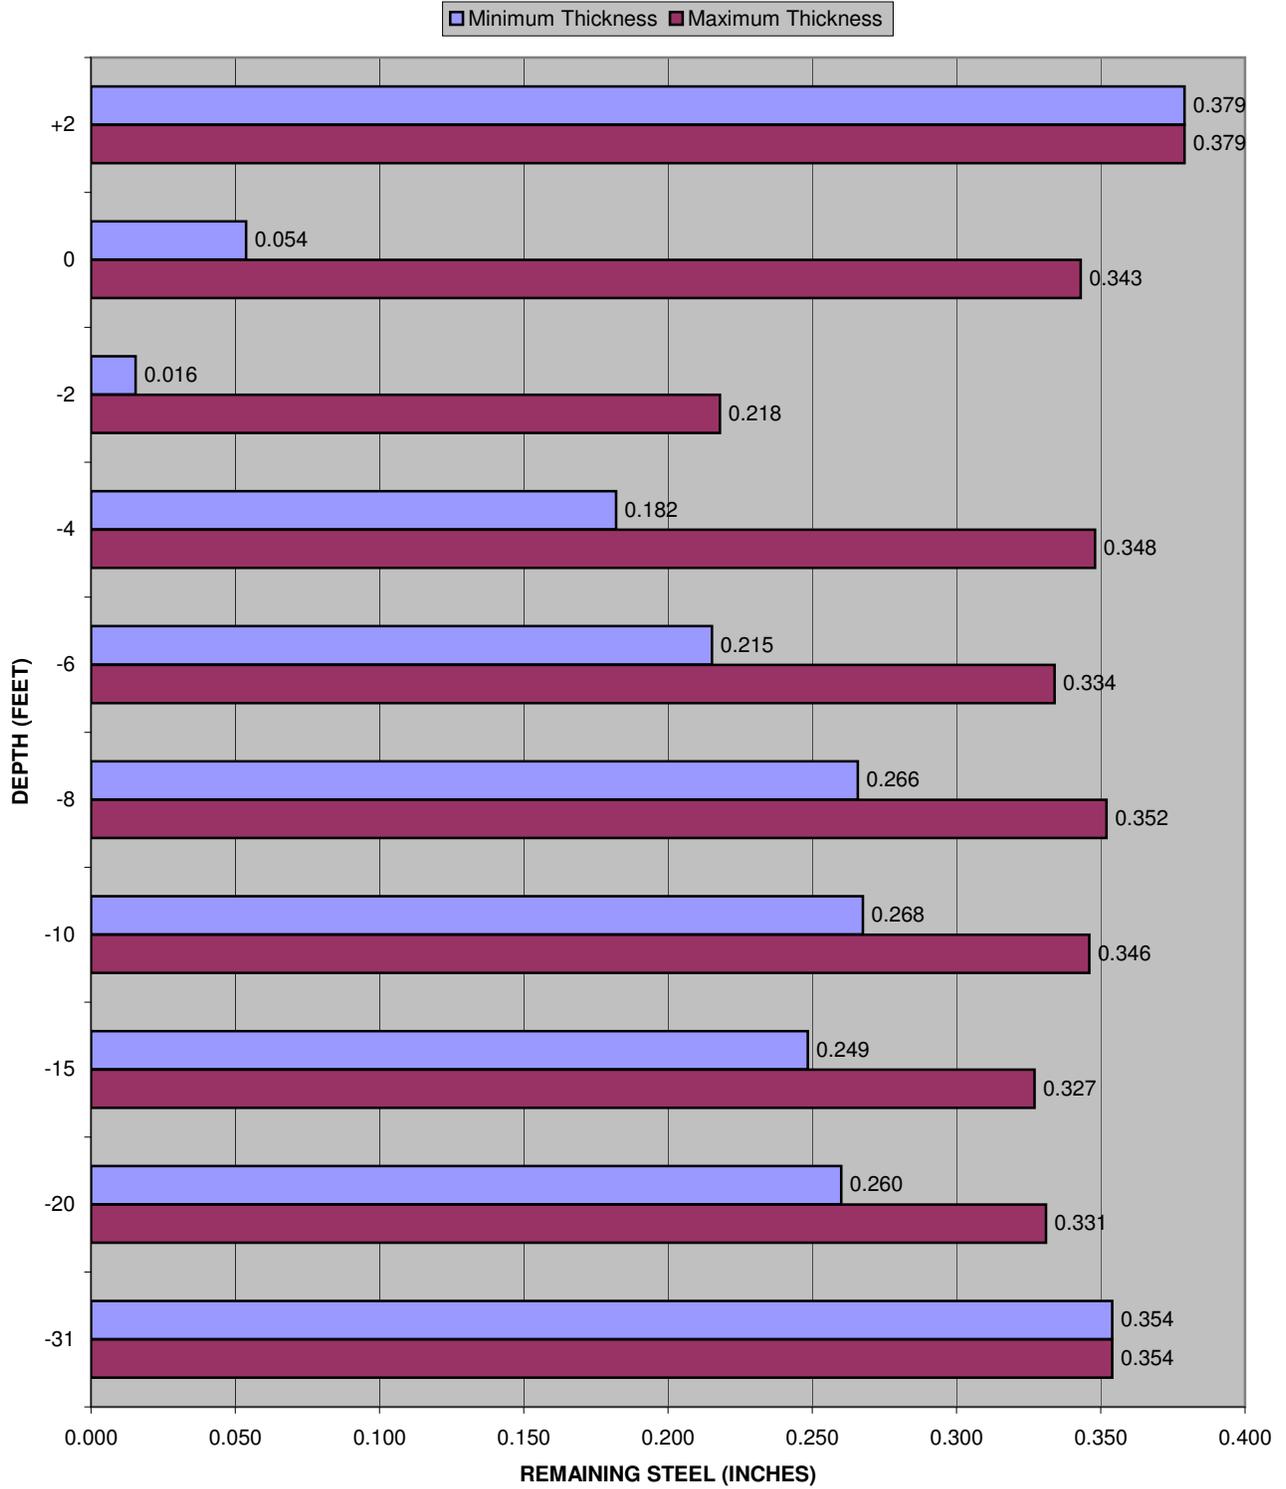
CARGILL DOCK- REMAINING STEEL
SITE I.D. # 7
(Measured Steel Thickness of 0.379 inches)

The Cargill bulkhead is owned and operated by Cargill Inc. The bulkhead consists of a steel sheet pile bulkhead with a metal cap. This facility only sees moderate use for the export shipping of general grains for foreign and domestic trade. The field data collection for this site included visual inspection and measurements of the corrosion present at elevations from IGLD to the mud line on the out pans and instantaneous water quality measurements. The steel at this site was perforated.

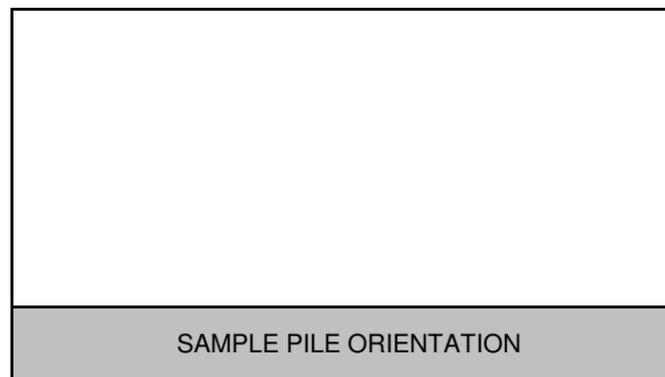
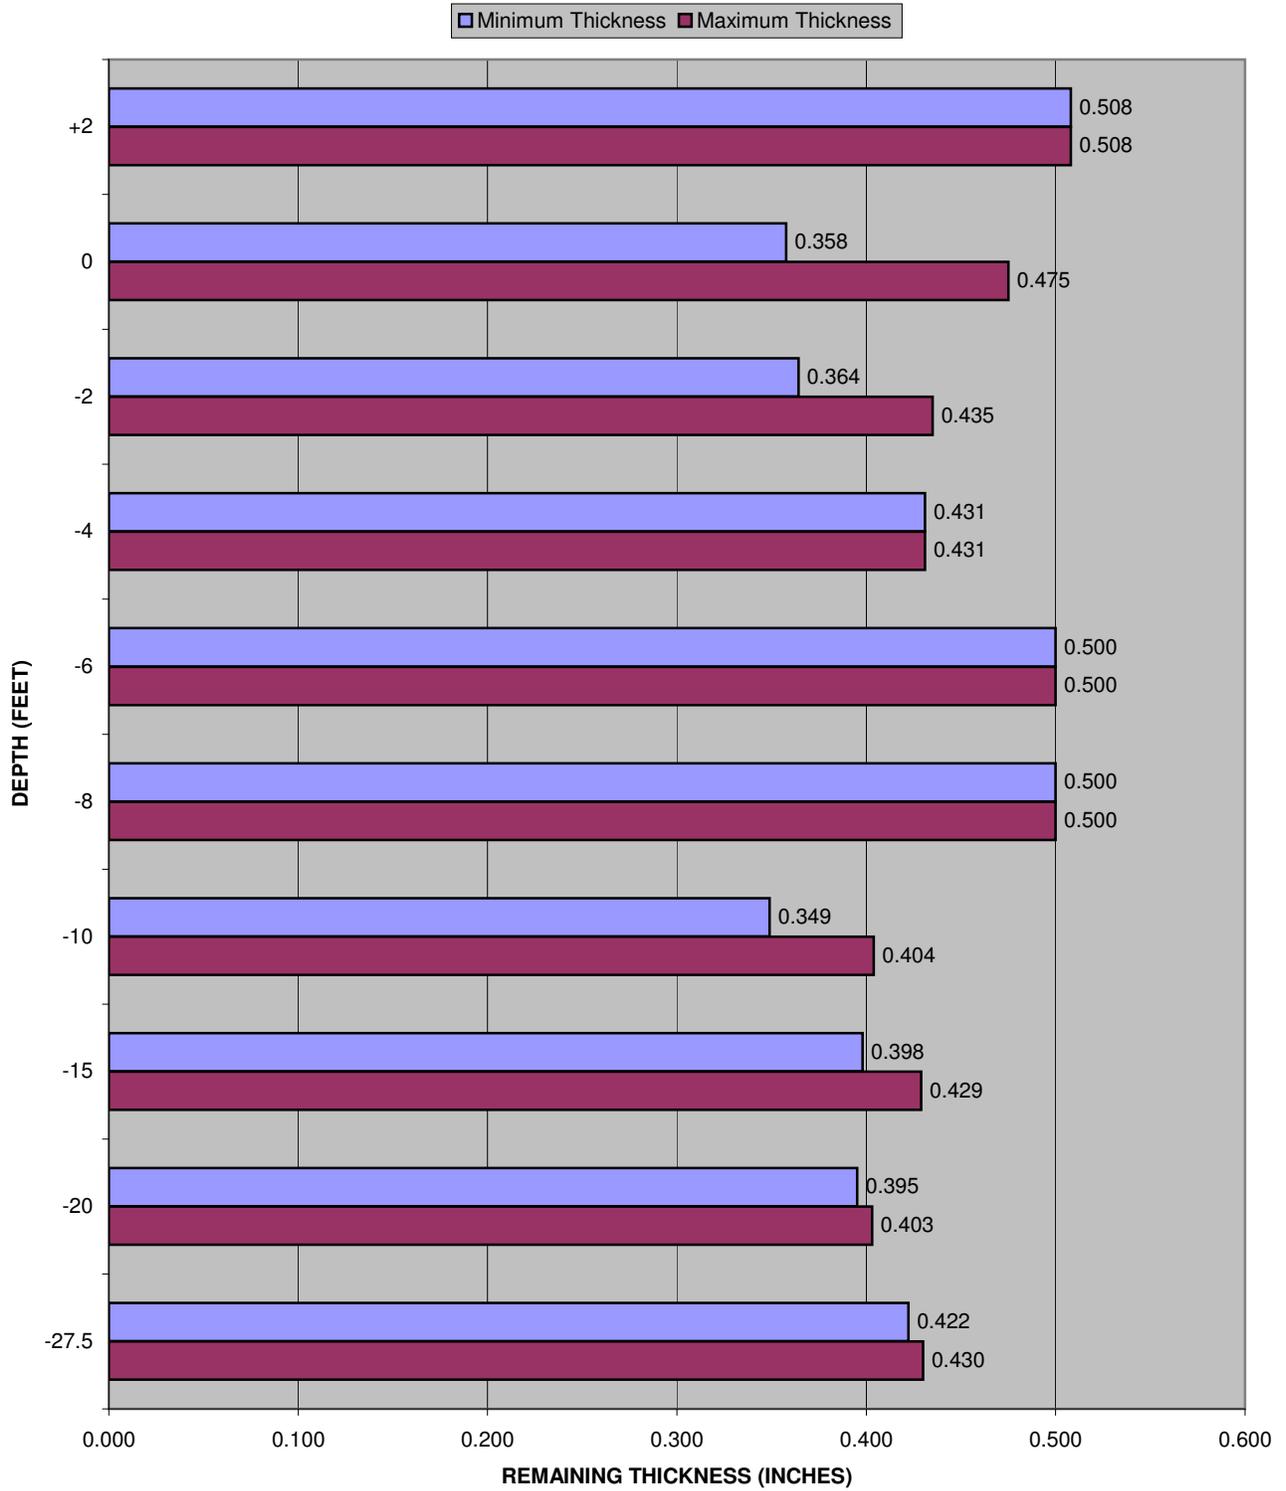
BONG BRIDGE CELL- REMAINING STEEL
SITE I.D. # 9
(Measured Steel Thickness of 0.508 inches)

STATION	Depth (IGLD +/-)	Marine Growth				Protective Coating				Corrosion			Steel Max. Remaining Thickness	Pit Penetration Readings					Pit Diameter Readings					Comments			
		Present	Type	Thickness	Coverage	Present	Type	Thickness	Coverage	Present	Type	Concentration (High Mod. Low)		Pit Penetration Readings					Pit Diameter Readings								
														1	2	3	4	AVG	1	2	3	4	AVG				
1	+2					x	Coal - Tar	unk	100%				0.508														
2	0	x	slime	<.25						x	Pitting	Mod	0.475	0.125	0.063	0.156	0.125	0.117	0.500	0.500	0.500	0.750	0.563		start pitting @ 0ft, coating gone below igld		
3	-2	x	mussels	.5 to .75	sporadic					x	Pitting	High	0.435	0.063	0.094	0.063	0.063	0.071	0.250	0.375	0.125	0.250	0.250		high concentration of small pits		
4	-4	x	mussels	.5 to .75	sporadic	x	Coal - Tar	unk	50%				0.431					0.000						0.000	did not remove coating		
5	-6	x	mussels, sponges	.75 to 1.5	100%	x	Coal - Tar	unk	100%				0.500					0.000						0.000	did not remove coating

6	-8	x	mussels	1.5 to 2	100%	x	Coal - Tar	unk	100%				0.500					0.000						0.000	coating ends		
7	-10	x	mussels, sponges	1.5 to 2	100%					x	Pitting	High	0.404	0.031	0.063	0.063	0.063	0.055	0.125	0.125	0.125	0.063	0.110		steel in good condition, etched surface		
8	-15	x	mussels	1.5 to 2	100%					x		High	0.429	0.031	0.031	0.031	0.031	0.031	0.500	0.375	0.750	0.750	0.594		ring pattern pits , etched surface		
9	-20	x	mussels	1.5 to 2	100%					x		Mod	0.403	0.031				0.008	0.500	0.375	0.500	0.500	0.469		ring pattern pits, etched surface		
10	-27.5	x	mussels	1.5 to 2	100%					x		Mod	0.430	0.031				0.008	0.250	0.125	0.250	0.125	0.188		27.5 feet deep, minor pitting, etched surface

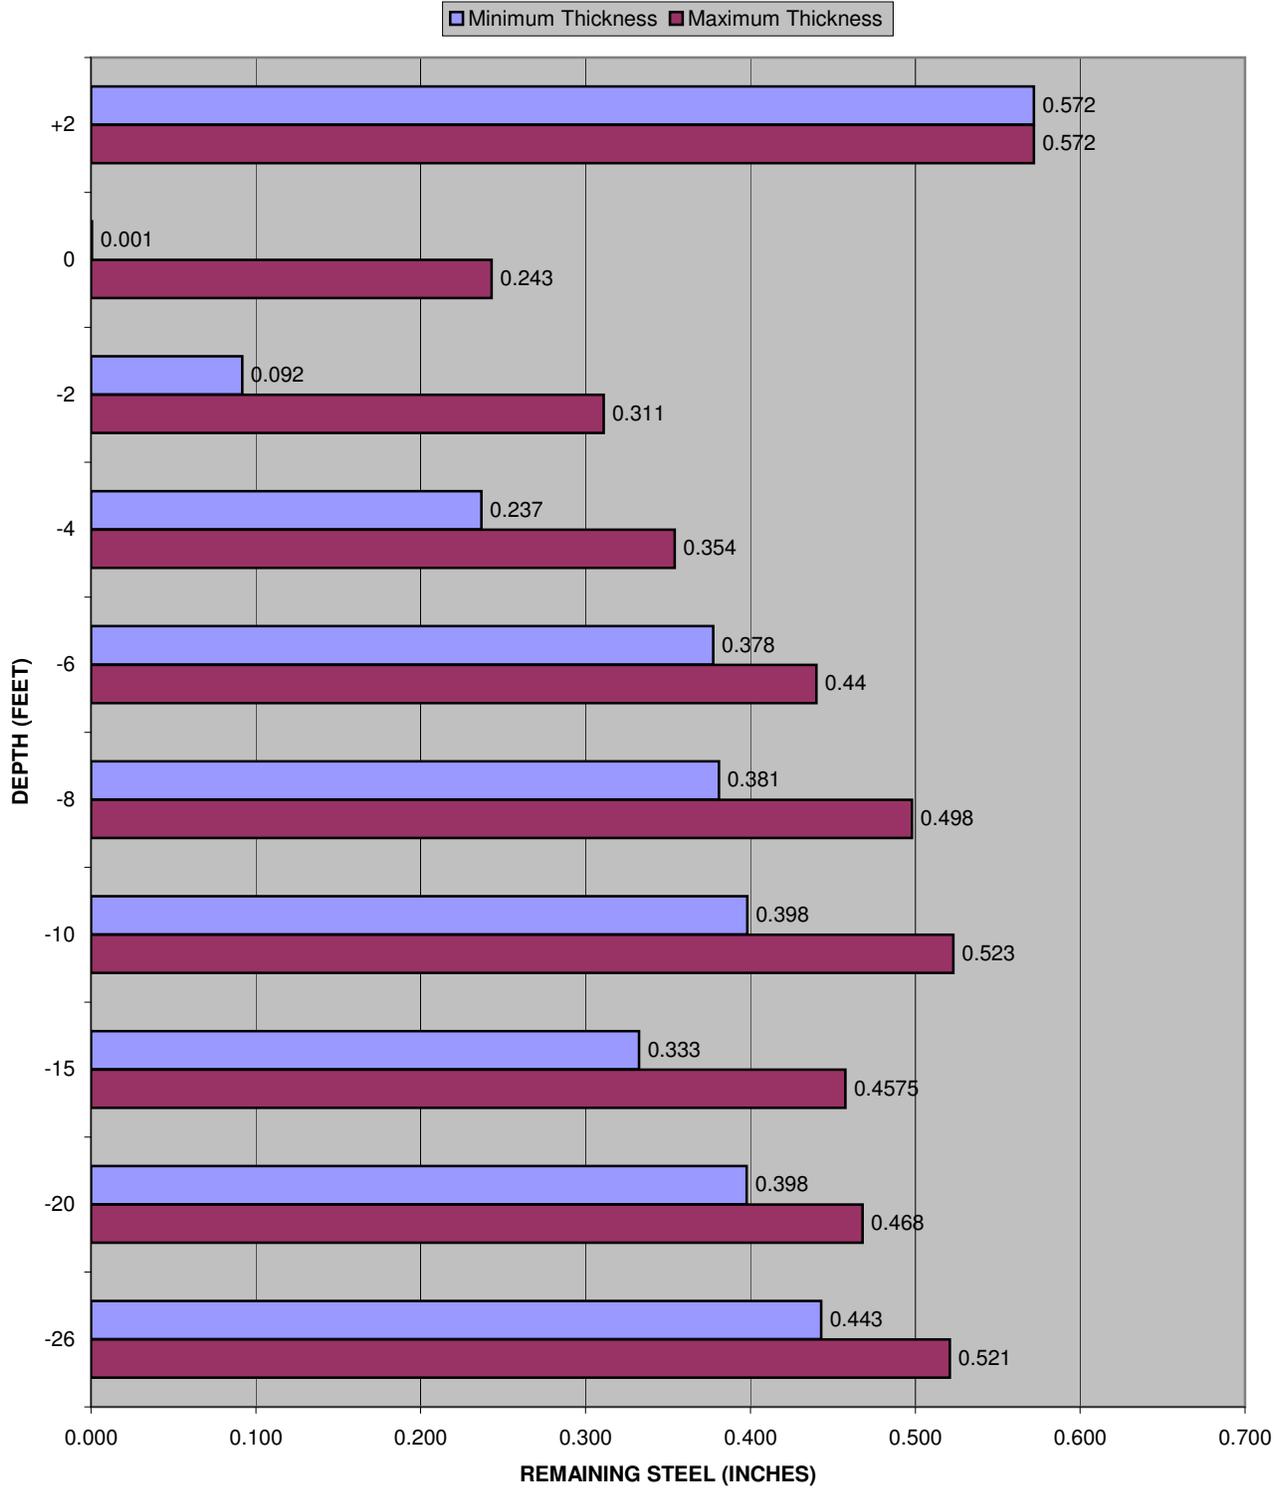
OLIVER BRIDGE- REMAINING STEEL
SITE I.D. # 12
(Measured Steel Thickness of 0.572 inches)

The Oliver Bridge is owned and operated privately by the CN Railway. The Bridge is primarily constructed with concrete piers. Due to a scour problem around the western pier, steel sheet piling was added to prevent undermining of the bridge pier foundation. The channels on each side of the bridge piers only see pleasure craft. The field data collection for this site included visual inspection and measurements of the corrosion present at elevations from IGLD to the mud line on the out pans, instantaneous water quality measurements and instantaneous corrosion measurements. This site was fitted with a coupon tray with coupons for measurements in 2007. It was also noted during a private bridge inspection that the steel nosing for ice breaking purposes on the upstream side of the bridge piers had heavy pitting which is consistent with the findings on the sheet piling.

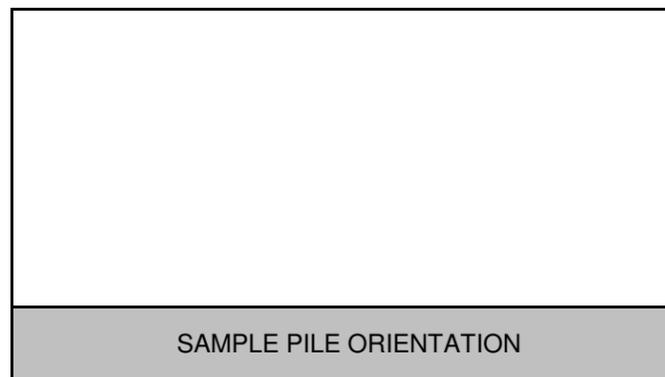
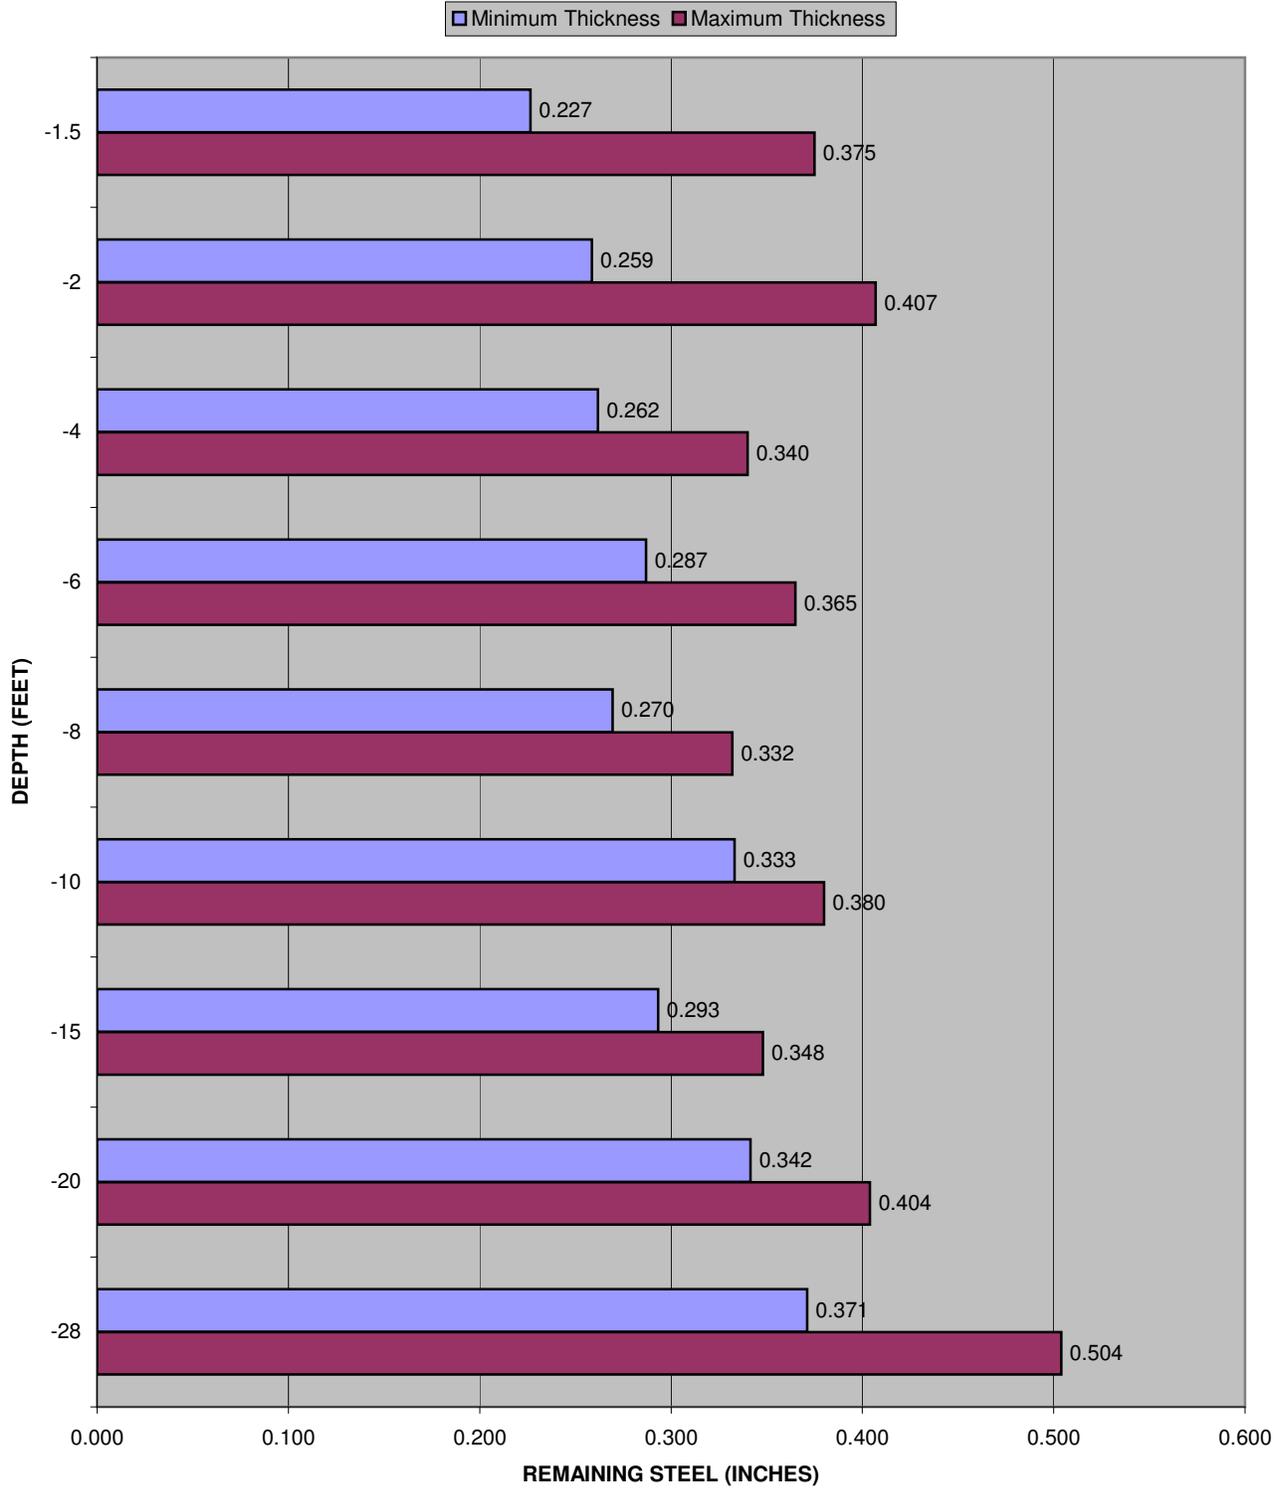
CENEX/ HARVEST STATES #1- REMAINING STEEL
SITE I.D. # 14
(Measured Steel Thickness of 0.504 inches)

STATION	Depth (IGLD +/-)	Marine Growth				Protective Coating				Corrosion			Steel Max. Remaining Thickness	Pit Penetration Readings					Pit Diameter Readings					Comments
		Present	Type	Thickness	Coverage	Present	Type	Thickness	Coverage	Present	Type	Concentration (High Mod. Low)		Pit Penetration Readings					Pit Diameter Readings					
														1	2	3	4	AVG	1	2	3	4	AVG	
1	+2																						Concrete Cap IglD To -1.5ft	
2	-1.5	x	ON, AL	.25 to .5	75-100					X	Pitting	High	0.375	0.125	0.125	0.156	0.188	0.148	0.625	0.750	0.625	0.750	0.688	Concrete Cap IglD To -1.5ft
3	-2	x	ON, AL	.25 to .5	75-100					X	Pitting	High	0.407	0.125	0.125	0.156	0.188	0.148	0.625	0.750	0.625	0.750	0.688	IP-OP SAME PIT
4	-4	x	ON, ZM, AL	.25 to .5	75-100					X	Pitting	High	0.340	0.125	0.063	0.063	0.063	0.078	0.500	0.500	0.500	0.375	0.469	IP SMALLER, OP LARGER PIT
5	-6	x	ON, ZM, AL	.25 to 1.5	75-100					X	Pitting	High	0.365	0.125	0.063	0.063	0.063	0.078	0.500	0.250	0.250	0.250	0.313	IP SMALLER, OP LARGER PIT

6	-8	x	ON, ZM, AL	.25 to 1.5	75-100					X	Pitting	High	0.332	0.063	0.063	0.063	0.063	0.063	0.250	0.250	0.188	0.250	0.234	IP SAME AS OP
7	-10	x	ON, ZM, AL	.25 to 1.5	50-50					X	Pitting	High	0.380	0.031	0.063	0.063	0.031	0.047	0.188	0.125	0.250	0.188	0.188	OP HIGHER PIT
8	-15	x	ON, ZM, AL	.25 to 1.5	50-50					X	Pitting	High	0.348	0.031	0.063	0.063	0.063	0.055	0.125	0.125	0.188	0.125	0.141	IP SAME AS OP
9	-20	x	ON, ZM, AL	.25 to 1.5	50-50					X	Pitting	Mod	0.404	0.063	0.063	0.063	0.063	0.063	0.250	0.250	0.125	0.125	0.188	IP SAME AS OP
10	-28	x	ON	.25 to .5	100-75					X	Pitting	Low	0.504	0.063	0.156	0.156	0.156	0.133	0.250	0.375	0.125	0.125	0.219	1' LIGHT SILT- IP SAME At ML AS OP

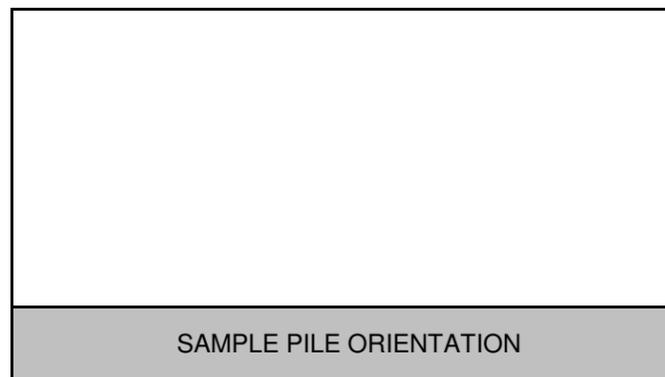
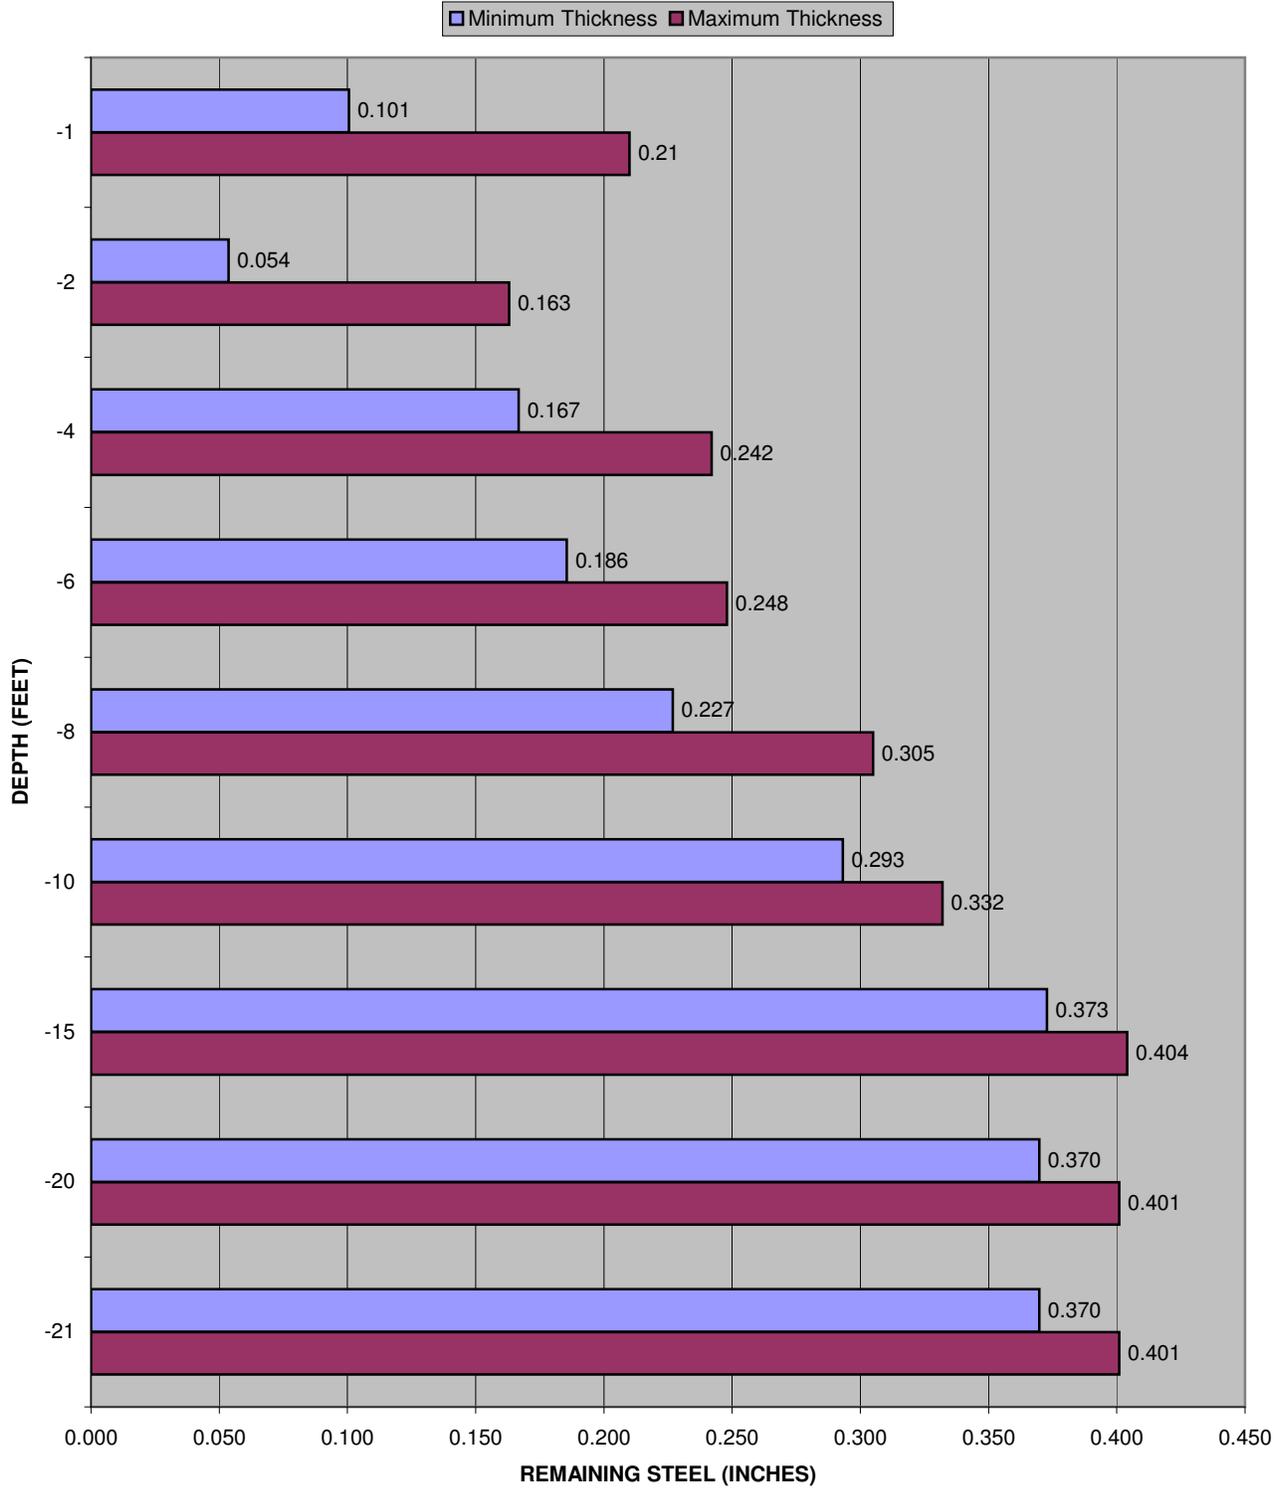
CENEX/ HARVEST STATES #2- REMAINING STEEL
SITE I.D. # 15
(Measured Steel Thickness of 0.404 inches)

STATION	Depth (IGLD +/-)	Marine Growth				Protective Coating				Corrosion			Steel Max. Remaining Thickness	Pit Penetration Readings					Pit Diameter Readings					Comments
		Present	Type	Thickness	Coverage	Present	Type	Thickness	Coverage	Present	Type	Concentration (High Mod. Low)		Pit Penetration Readings					Pit Diameter Readings					
														1	2	3	4	AVG	1	2	3	4	AVG	
1	+2																						Concrete Cap	
2	-1	X	ZM	1	100%					x	Pitting	High	0.21	0.125	0.125	0.125	0.063	0.109	0.375	0.250	0.250	0.375	0.313	Sheets Start 1ft Below IGLD
3	-2	X	ZM	1	100%					x	Pitting	High	0.163	0.125	0.125	0.125	0.063	0.109	0.375	0.250	0.250	0.375	0.313	IP of Same
4	-4	X	ZM, SP	1.5	100%					x	Pitting	High	0.242	0.063	0.082	0.094	0.063	0.075	0.250	0.500	0.500	0.375	0.406	IP OP Same
5	-6	X	ZM	1.5	100%					x	Pitting	High	0.248	0.063	0.063	0.063	0.063	0.063	0.250	0.250	0.250	0.250	0.250	IP OP Same
6	-8	X	ZM, SP	1.5	100%					x	Pitting	High	0.305	0.063	0.094	0.063	0.094	0.078	0.250	0.375	0.375	0.500	0.375	OP Heavy Pit thru IP

7	-10	X	ZM, SP	1.5	100%					x	Pitting	High	0.332	0.031	0.031	0.063	0.031	0.039	0.250	0.375	0.250	0.375	0.313	IP same as OP
8	-15	X	ZM	1.5	100%					x	Pitting	High	0.444	0.031	0.031	0.031	0.031	0.031	0.188	0.063	0.188	0.375	0.203	IP same as OP
9	-20	X	ZM	1.5	50%					x	Pitting	Low	0.401	0.031	0.031	0.031	0.031	0.031	0.188	0.063	0.188	0.063	0.125	IP same as OP
10	-21	X	ZM	1.5	50%					x	Pitting	Low	0.401	0.031	0.031	0.031	0.031	0.031	0.188	0.063	0.188	0.063	0.125	IP same as OP

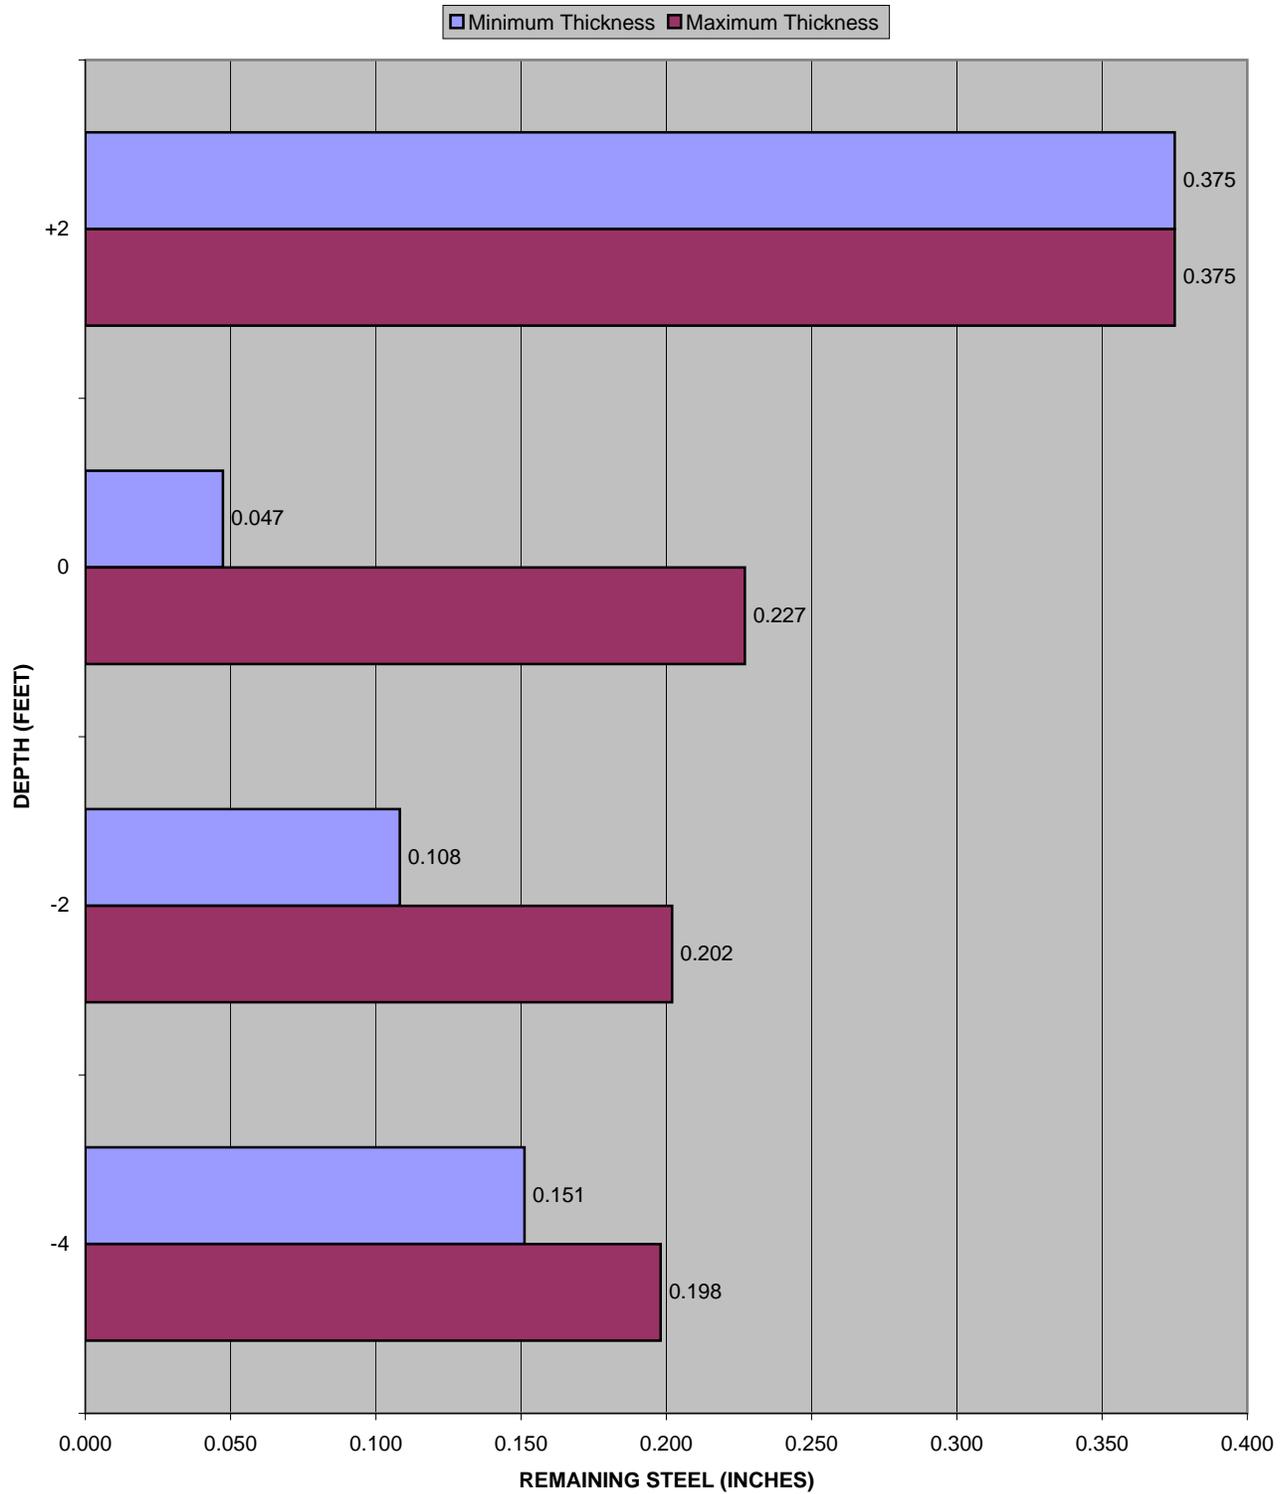
LAKEHEAD BOAT BASIN #2- REMAINING STEEL
SITE I.D. # 19
(Measured Steel Thickness of 0.375 inches)

The Lakehead Boat Basin is owned and operated by Joel Johnson. The bulkhead consists of a steel sheet pile bulkhead with a metal cap. This facility sees moderate use by both charter and private recreational boats. The field data collection for this site included visual inspection and measurements of the corrosion present at elevations from IGLD to the mud line on the out pans and instantaneous water quality measurements. The general water depth was very shallow along the bulkhead inspected and perforations were present.
