Duluth-Superior Harbor Freshwater Corrosion Update

Gene Clark, P.E.¹, Dave Bowman, P.E.², Jim Sharrow, P.E.³, Chad Scott, P.E.⁴
and Randall Hicks, Ph.D.⁵

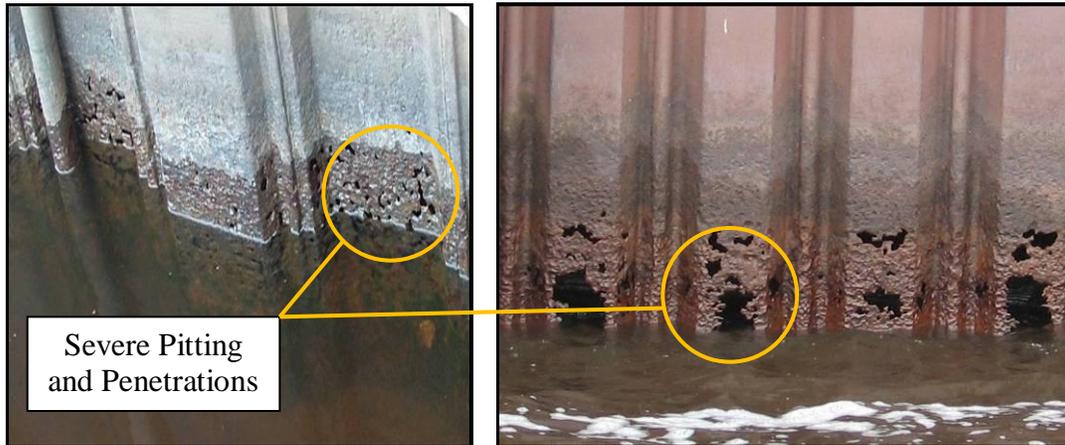
The Duluth, Minnesota and Superior, Wisconsin shared harbor is located on Lake Superior and fed fresh water by the St. Louis and Nemadji Rivers. In 1998, it was discovered that many marine structures in the DSH were experiencing significant corrosion and pitting levels higher than typically experienced in fresh water harbors. Figure 1 shows severe corrosion levels characteristic on harbor structures.

Figure 1. Typical Corrosion Found on DSH Sheet Pile Structures

Investigations initiated by the study team have found that advanced pitting is found on all unprotected steel structures in the DSH. The corrosion is especially pronounced in areas around 0.5 to 3.3 meters (1 to 10 ft) below water surface levels. Depths greater than 3.3 meters show little to no corrosion. Table 1 shows a summary of the average corrosion rates and pitting found at different depths.

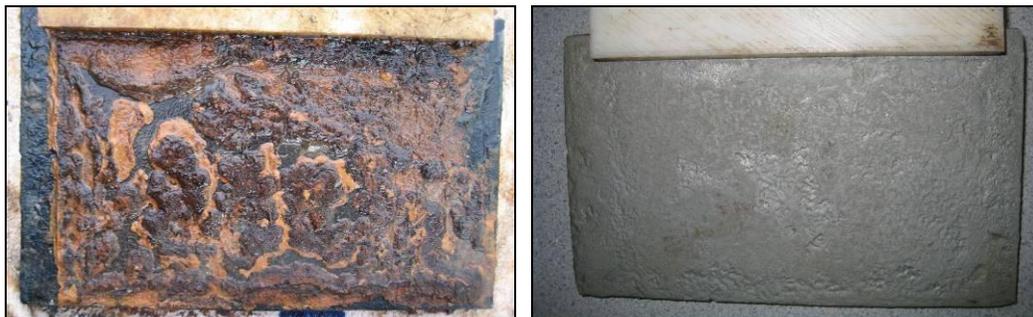
To measure and monitor current corrosion rates in the harbor, a series of test samples were installed at several DSH sites in 2006 and 2008. At each location, eight 10mm (3/8 in) thick uncoated steel coupons with measured weights and dimensions were installed at a depth of 1.2 meters (4 feet). A coupon is removed from each site every 6 months, cleaned, and measured to determine its physical losses and pitting depths. Examples of sample appearance before cleaning (left image) and after (right image) are shown in Figure 2.

Figure 2. Uncoated Test Coupon Before and After Cleaning

Results of the testing to date show uniform corrosion rates between 0.043 mm to 0.095 mm (1.7 to 3.7 mils) loss per year which is consistent with the long term degradation rates shown in Table 1.

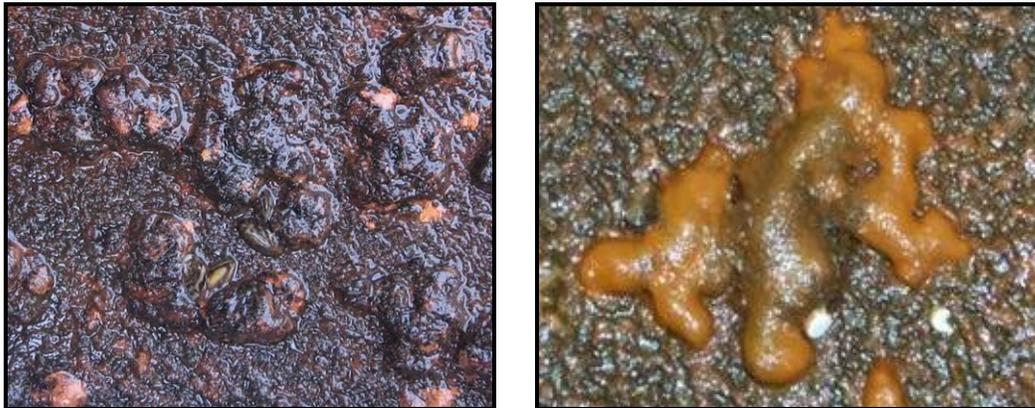
Observations have also shown that severely corroded areas are usually accompanied by orange tubercle growths on the surface of the steel. Figure 3 shows the appearance of the tubercles before (left figure) and after (right figure) cleaning in a lab environment.

Figure 3. Tubercle Growths Associated With Corrosion

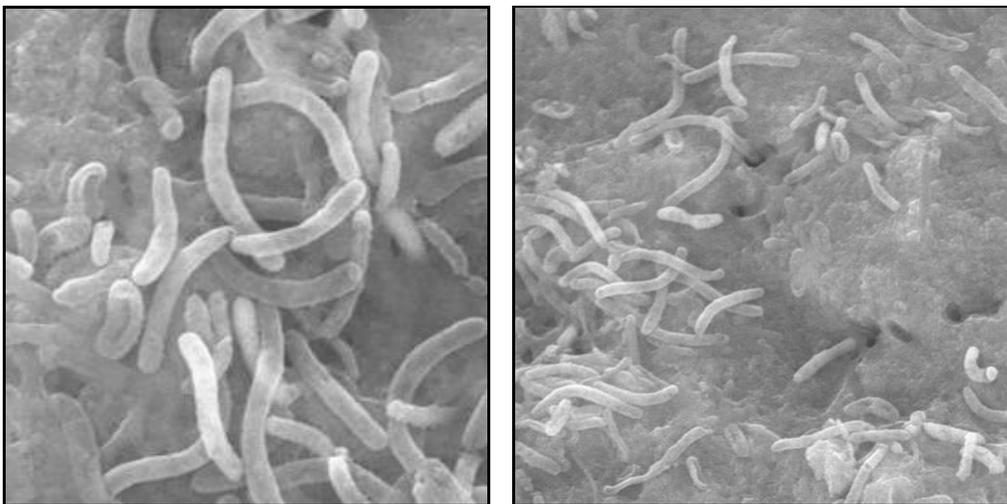
Analysis by the University of Minnesota Duluth and the Naval Research Laboratory of the test coupons installed in the harbor in 2006 to 2008 show that a probable principle corrosion acceleration mechanism is Microbiologically Influenced Corrosion (MIC). MIC is a general term for corrosion resulting from the presence and activities of micro-organisms on and near steel structures, and is not normally found in fresh water harbors.

In-situ biological samples are collected from the test coupons removed from the harbor and are then tested for DNA structure, cultured, and analyzed using electron microscope technology. Figure 4 shows examples of micro-organisms found on tubercle growths (left image) and steel test coupons (right image) as observed through an electron microscope.

Figure 4. Micro-Organisms Viewed Through Electron Microscope

Presence of these micro-organisms results in small physical or chemical differences in the metals or surrounding environment which has been shown to cause pitting, crevice corrosion, differential aeration cells, metal concentration cells, selective de-alloying, increased erosion, and increased galvanic corrosion.

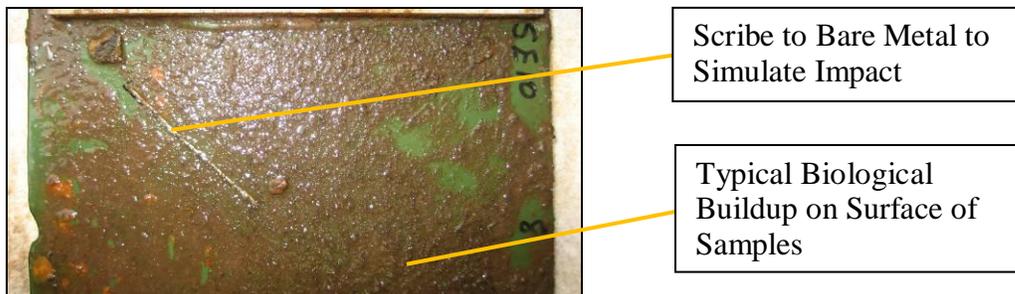
In late 2008, the coupons were removed from each of the test sites and inspected. Visual observations were documented on all samples, and some coupons were analyzed for corrosion loss and biological growth testing. Analysis showed no signs of loss of adhesion anywhere including near the scribed areas. A typical coated test sample removed for inspection is shown in Figure 5.

Figure 5. Coated Test Coupon

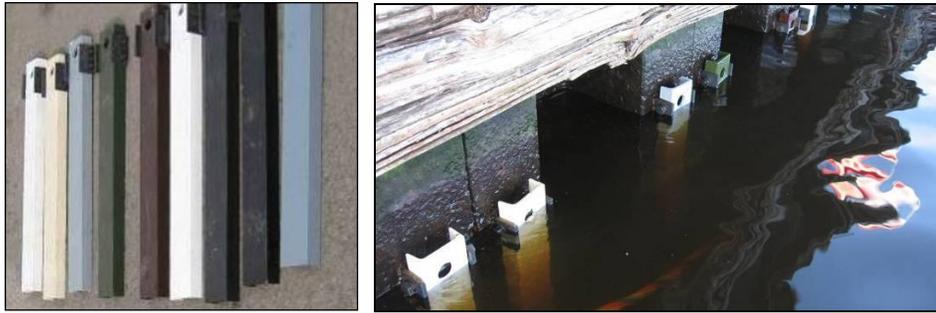
The impact test installed a total of 18 total samples, each coated with one of 9 different coatings. Shown in the left image of Figure 6, the 1 meter (3 ft) long samples were fabricated from steel channels, sandblasted, coated, and mounted on a pier along a high shipping traffic channel in the harbor. The samples were installed in the heaviest ice impact and corrosion zones, with their top edges just above MLW (Mean Low Water datum) as shown in the right image of Figure 6. The test samples will be inspected yearly and coating thicknesses, adhesion, and overall conditions will be recorded.

Figure 6. Ice Abrasion Samples Before and After Installation

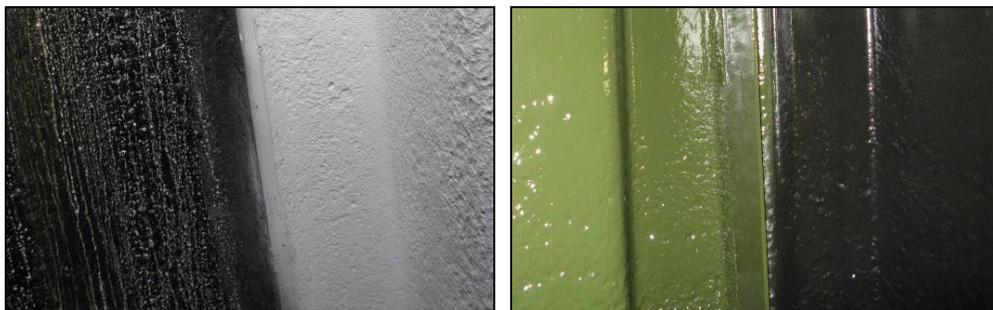
In August of 2009, a full scale test was initiated to evaluate the ability of different coatings to protect existing corroded steel sheet piling from further corrosion as well as withstand ice forces. Eight different and unique coatings with good impact resistance and rapid cure times were installed adjacently on a sheet pile wall near a high ship traffic area in the harbor. Approximately 170 square feet of each coating were installed from a portable cofferdam after sandblasting the metal to SSPC-10. The coated surfaces extended from about 0.7 meter (2 feet) above to 3.3 meter (10 ft) below the harbor water line. An example coating application is shown in Figure 7.

Figure 7. Side By Side Full Scale Corroded Sheet Pile Coating Trial Examples

Each coating will be evaluated for ease of installation, cost, corrosion prevention, ability to resist ice abrasion and impact, as well as bonding adhesion to the base metal. Testing and evaluations will be performed initially and on a yearly basis to ascertain each product's thickness losses, adhesion, and overall condition and performance in harbor conditions. Results of the all sample and full scale corrosion, abrasion and impact monitoring will be published for use in the DSH and other fresh cold water regions.

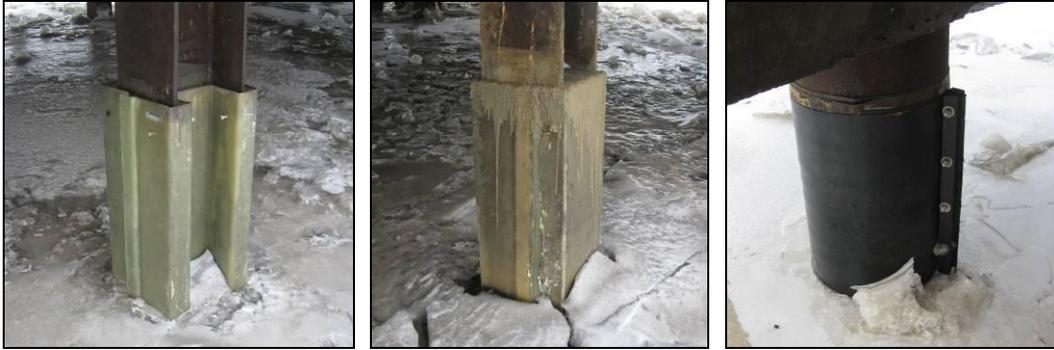
The final system is designed to protect cylindrical steel pipe pile. The outer jacket cover of this system is fabricated from high density polyethylene (HDPE). Petrolatum paste is used to fill any large pits on the steel surface and create a seal to prevent direct contact between water and steel and resulting corrosion. The jacket is installed and joined with bolts which are tightened to force out any water and air, and protect the inner corrosion inhibiting components from damage by external forces. Pictures of the H-Shaped (left figure), rectangular (middle figure) and pipe (right figure) protective systems are shown in Figure 8.

Figure 8. H-Shaped, Rectangular, and Pipe Pile Protective Systems

The project team inspected the three pile protection systems in the spring of 2009 and all systems survived the winter of 2008-2009 severe ice conditions without damage and remain sound. The team will continue with systematic yearly observations of each system's ability to withstand ice impact and abrasion forces and publish results for use by harbor and other cold region port facility owners and managers.

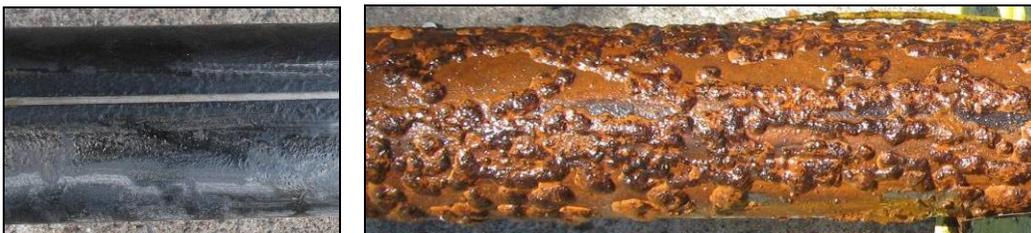
Preliminary observations show that CPS systems appear to be effective against DSH corrosion, although some tubercle growth has been observed on protected samples - although less severe than those unprotected. Figure 9 shows the condition of a coated pipe with no visible corrosion (left image) and the tubercle growths forming on the unprotected sample (right image) after only 8 months of immersion.

Figure 9. Pipe Samples With and Without Cathodic Protection

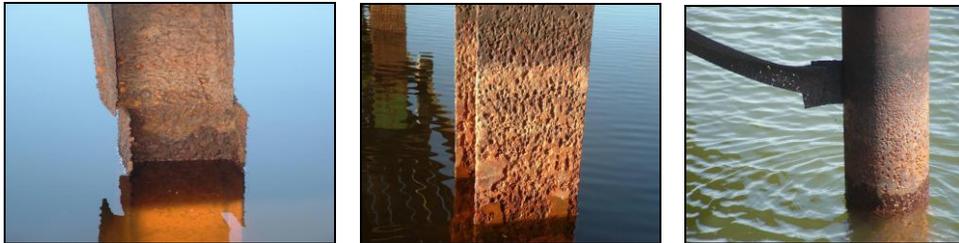
Once the accelerated corrosion in the DSH had been discovered and reported, other Great Lakes ports and harbors also started to observe steel corrosion concerns in some structures, although usually not as severe as in the DSH. In the summer of 2009, a full inspection of another corroded Lake Superior harbor structure was conducted. Water, biological and steel samples were collected for analysis to compare corrosion and environmental conditions to the DSH. Visual observations and non destructive testing show the corrosion levels and overall deterioration to be very similar to the DSH; with the only notable difference being the lack of zebra mussels at the site. Figure 10 shows an example from this location (left figure) while the center and right figures are examples from other Lake Superior harbors.

Figure 10. Other Harbors With Lake Superior Corrosion Examples
