**EXISTING STEEL COUPON EVALUATION AND ICE
ABRASION SAMPLE INSTALLATION FOR DULUTH HARBOR
CORROSION STUDY**

DULUTH-SUPERIOR HARBOR

EXISTING STEEL COUPON EVALUATION AND ICE ABRASION SAMPLE INSTALLATION FOR DULUTH HARBOR CORROSION STUDY

Duluth-Superior Harbor
November, 2008

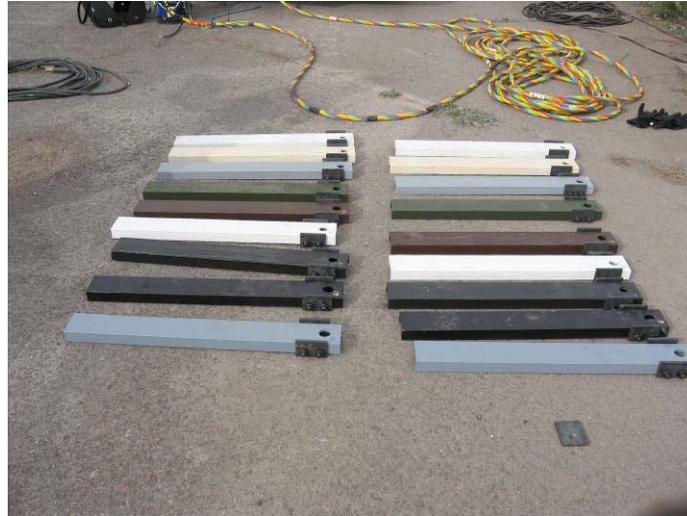
Picture 1: Uninstalled Ice Abrasion Samples

The Ice Abrasion Samples were 3'-0" lengths of C6X8.2 channel fabricated from A36 steel. Steel tabs composed of 1/2" thick A36 steel were welded to the sheet piling at the top and bottom of the samples. 8" x 3/4" bolts were used to hold the samples to the steel sheet piling during the study. The uninstalled samples with the top connector tabs are shown below in Picture 1.

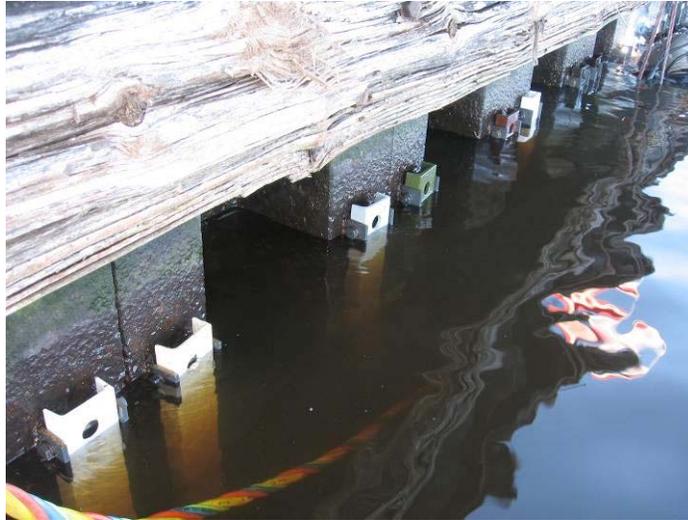
Picture 2: Installed Ice Abrasion Samples

At the time of installation the water datum varied from 3" to 6" above mean low water (MLW) which is 601.1' above sea level. The coordinates that these samples were installed are at N46°45'23.94", W92°5'42.69"W at the Duluth Seaway Port Authority facility. The samples were installed so the top of the ice abrasion samples are located 6" above MLW. This elevation was chosen so the samples would be in the heaviest ice zone during the winter months. The samples in place when the water was approximately 3" above MLW can be seen below in Picture 2.
