Cat Island Chain Restoration, Green Bay

Victoria Harris, UW Sea Grant

January 27, 2005

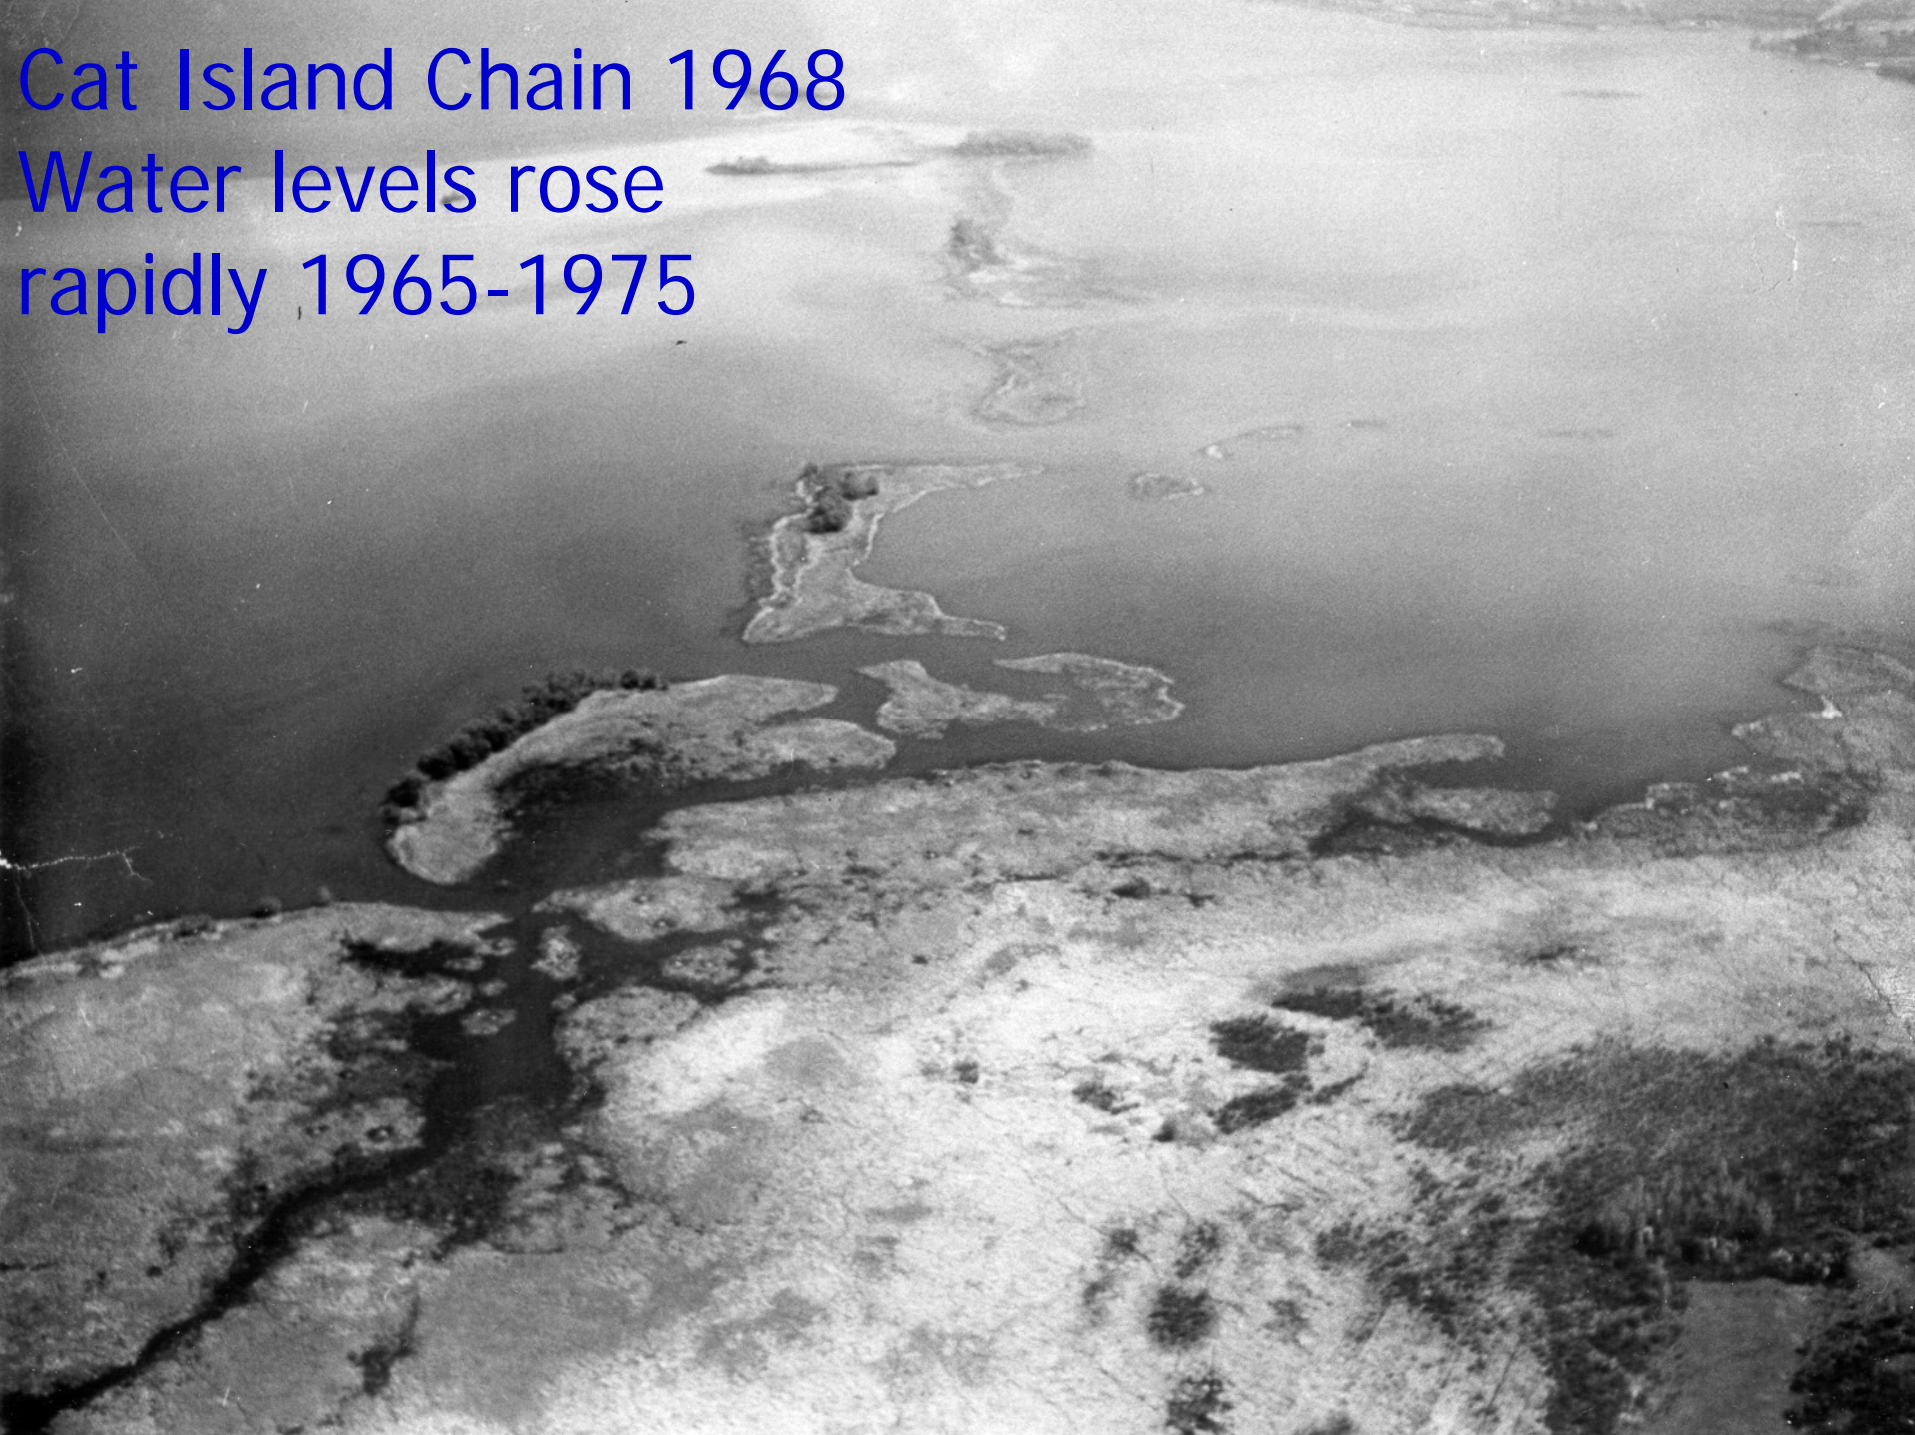
Cat Island Chain 1968
Water levels rose
rapidly 1965-1975

An aerial photograph showing a coastal wetland area. The image is divided into several regions, each labeled with white text. At the top, there are several long, narrow islands or points of land. Below these, a larger area of water is visible, followed by a marshy area with a network of waterways. In the foreground, there is a large, brown, excavated area, likely a construction site, and a road. The overall scene depicts a complex landscape of water, land, and human activity.

Long Tail Point

Cat Island

Bass Islands

Duck Creek Delta Marsh

Landfill

I-43 Construction

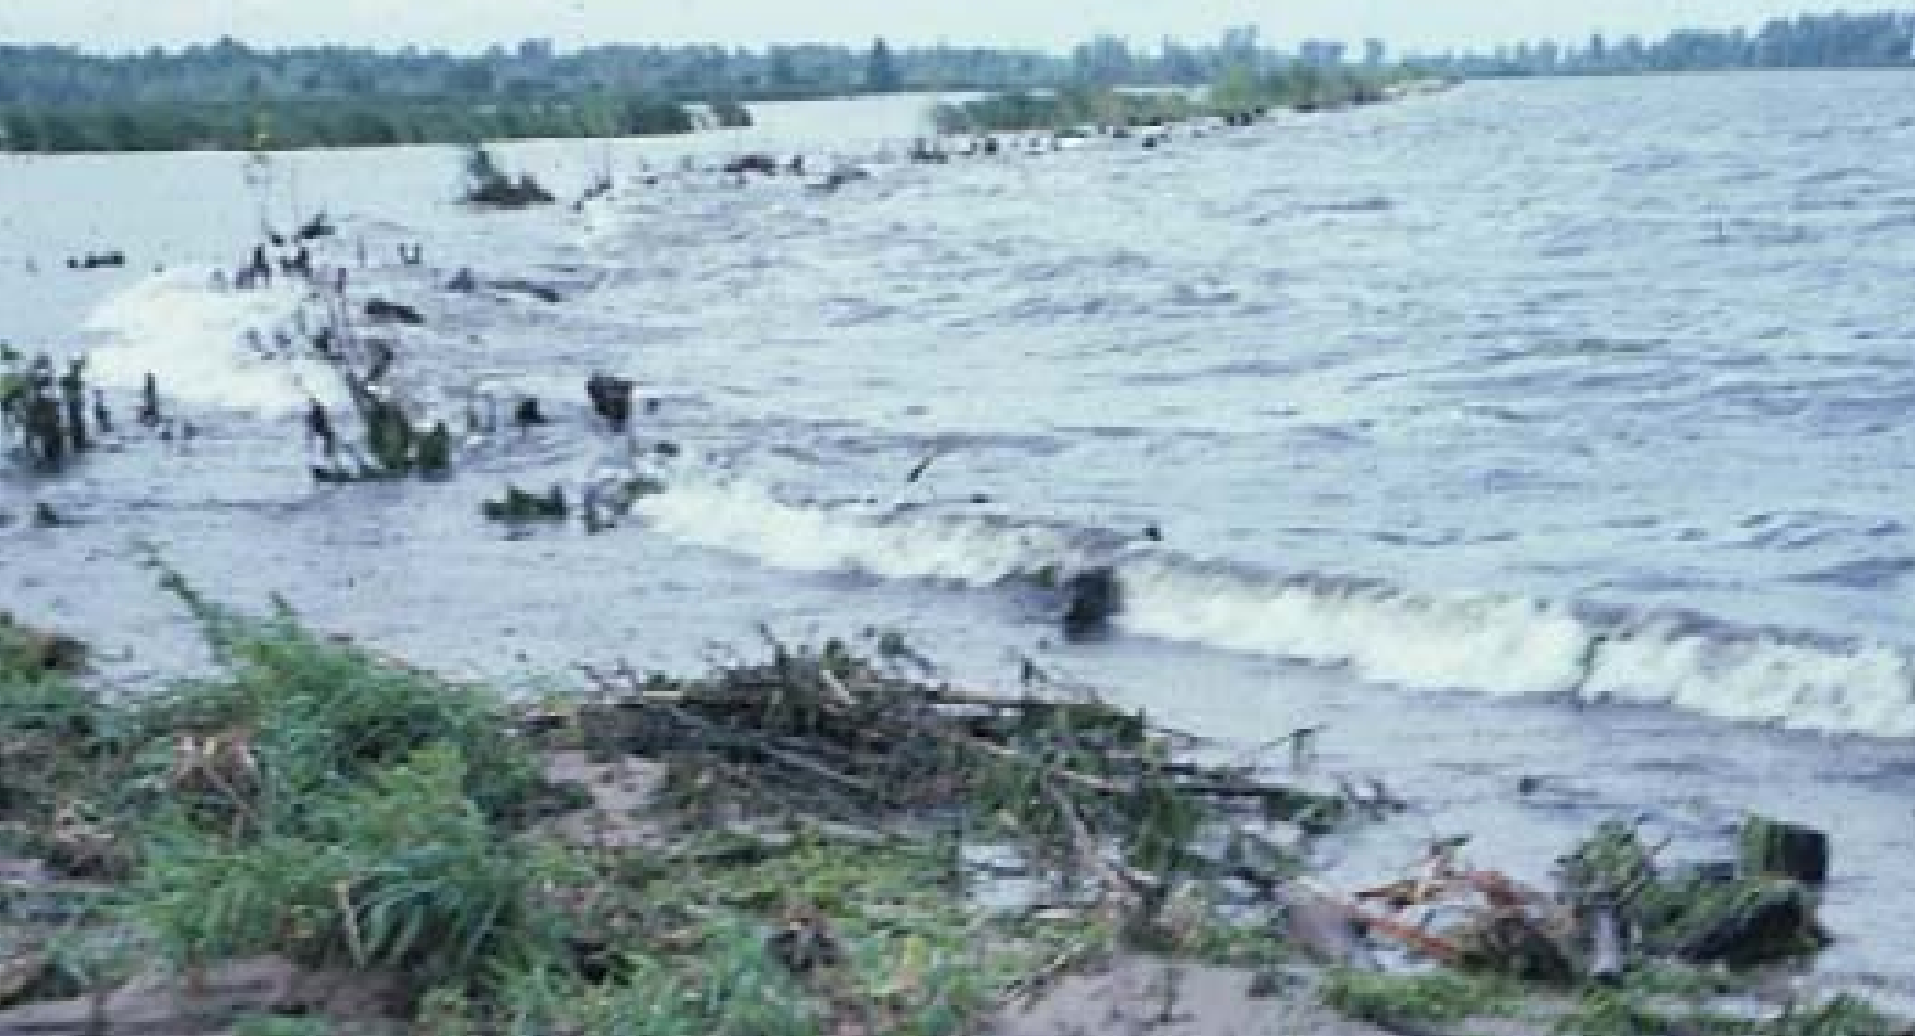
Green Bay Islands during
low water levels in 1966

Bass Islands

Willow Is.

Cat Island

Navigation Channel

Lone Tree Is.

Grassy Is.

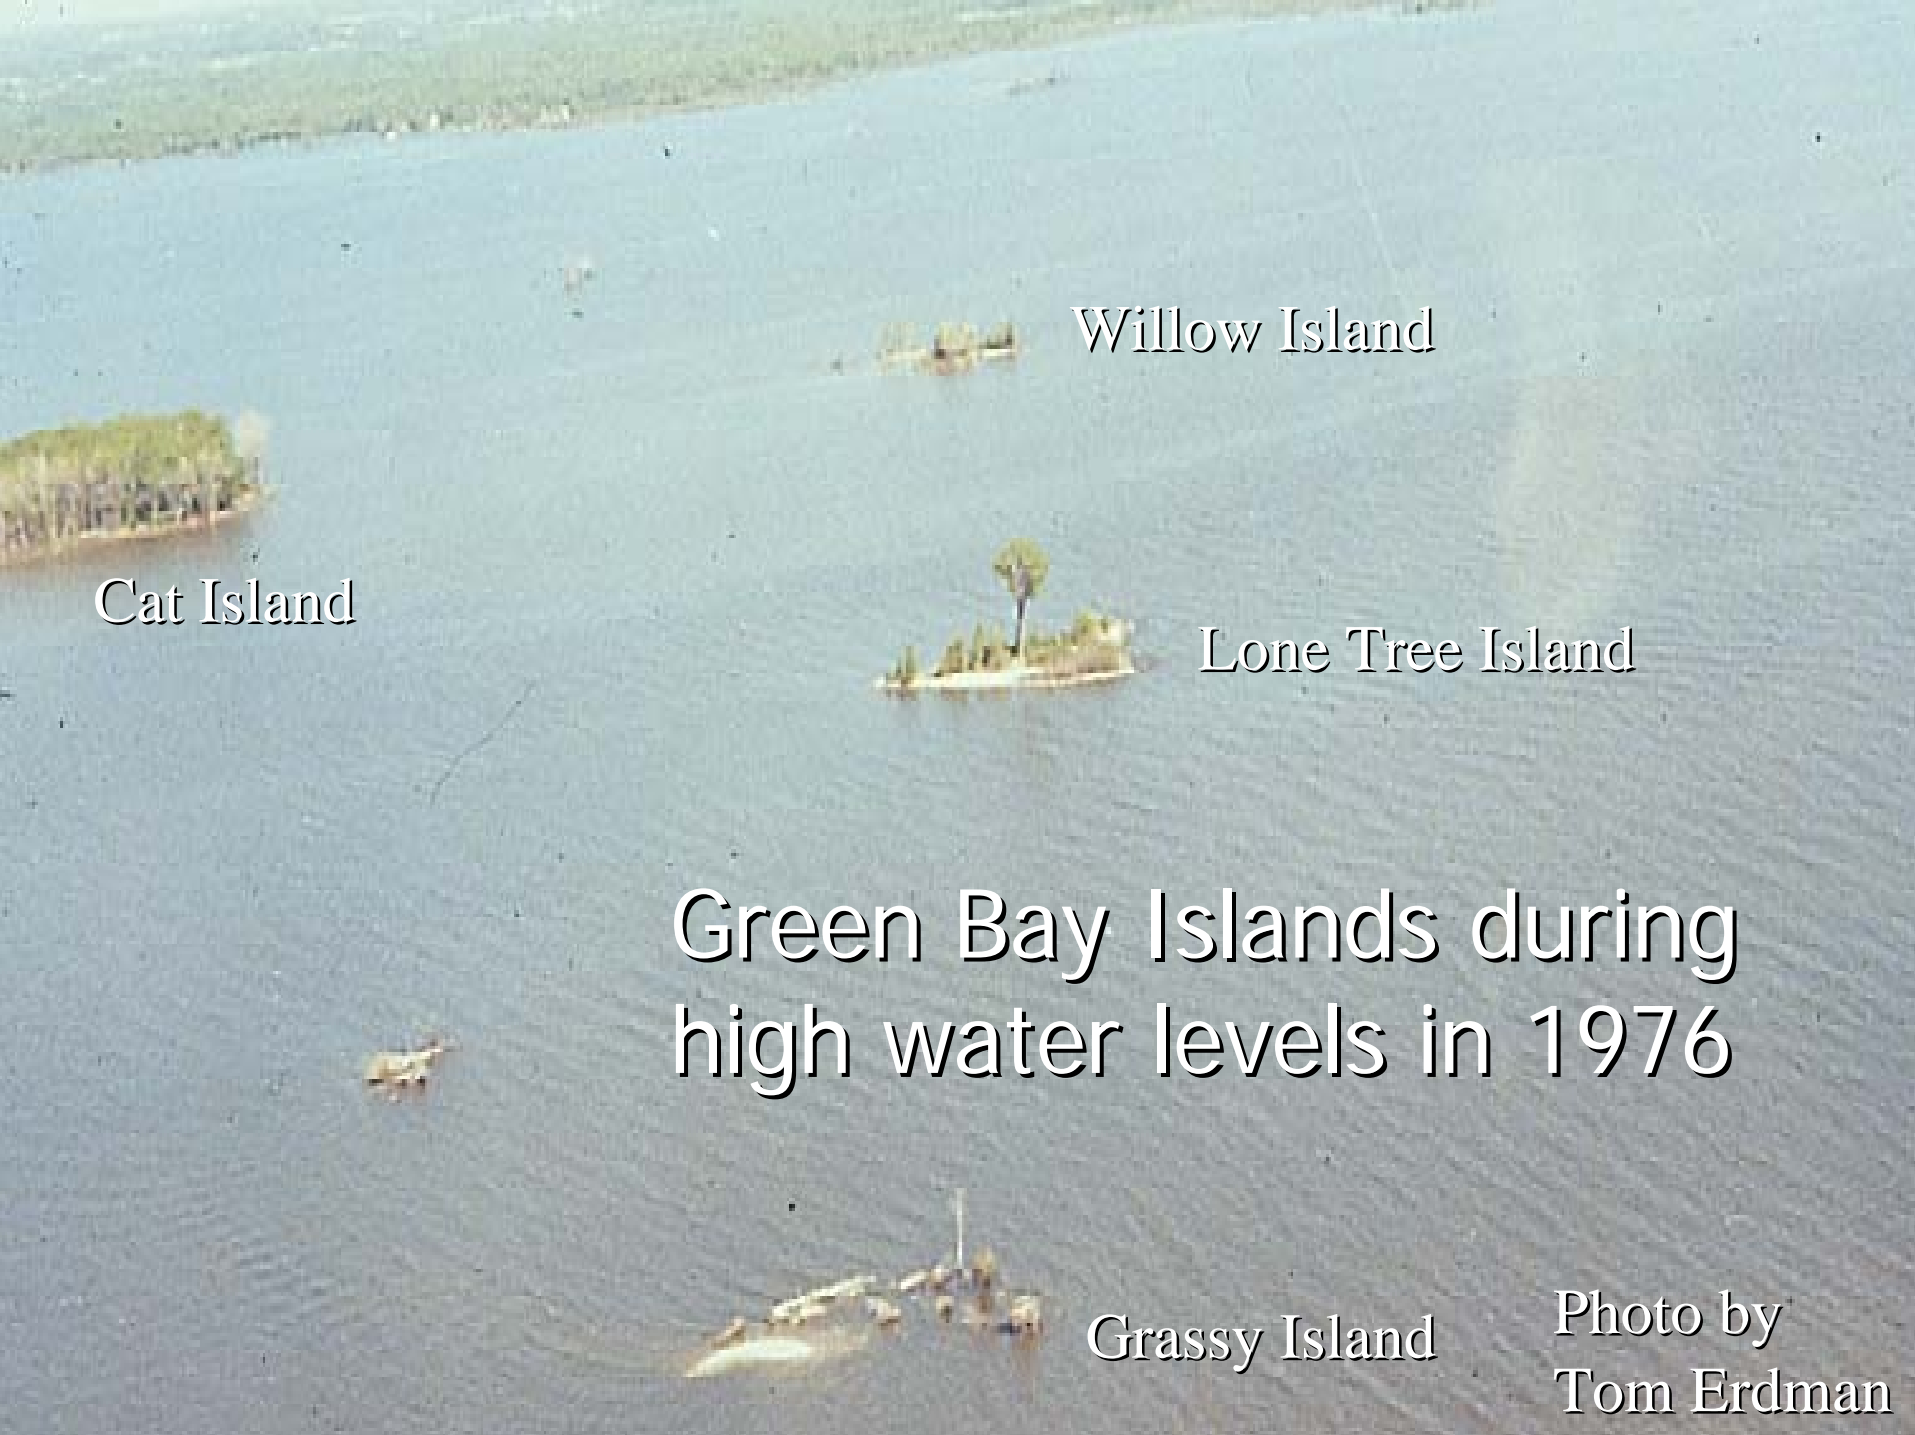
Green Bay Islands during
high water levels in 1976

Willow Island

Cat Island

Lone Tree Island

Grassy Island

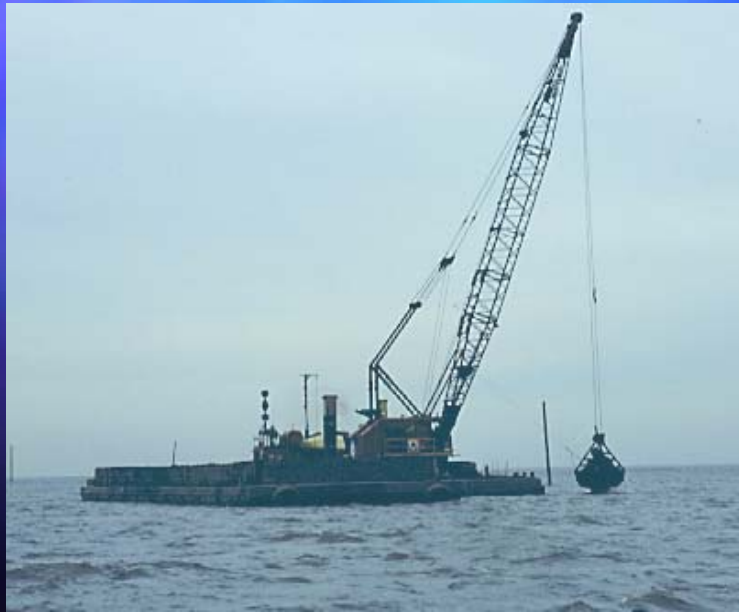
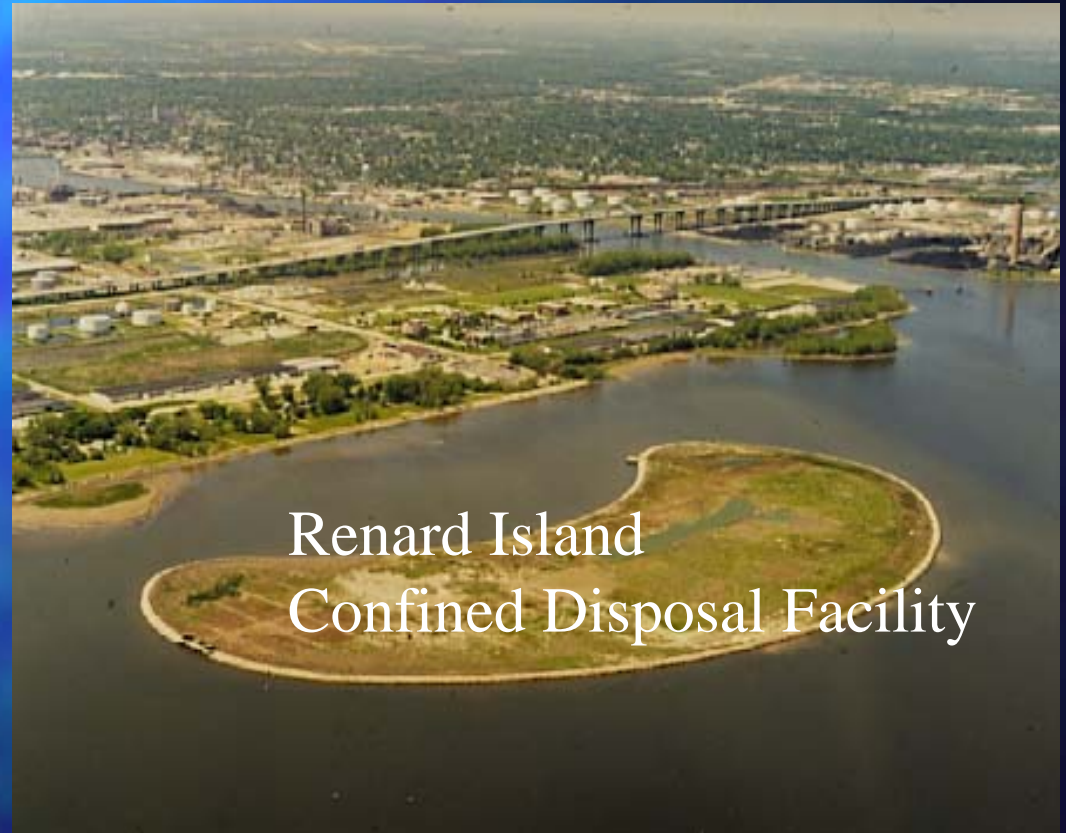
Cat Island Ecosystem Restoration

- Several proposals by RAP from 1989 - 96
- Section 204 Water Resource Development Act Agreement with Brown County in 1996 (max \$ 5 million)
- Partnership between USACE, Brown Co., and RAP Biota & Habitat (US FWS, WDNR, UW Sea Grant and others)

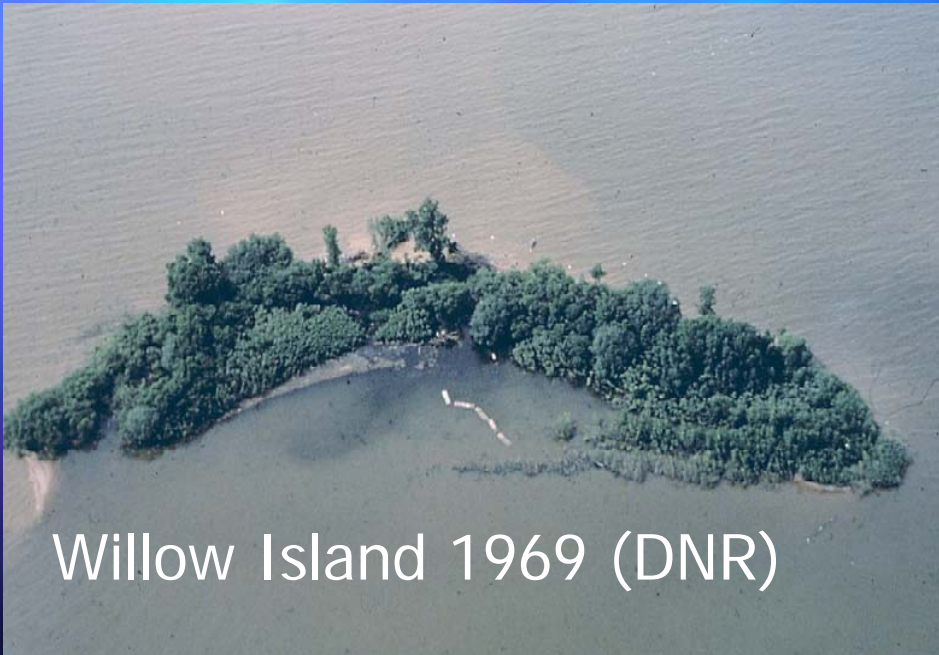
Willow Island 1969 (DNR)

Background PCB Concentrations in Vicinity of the Cat Islands

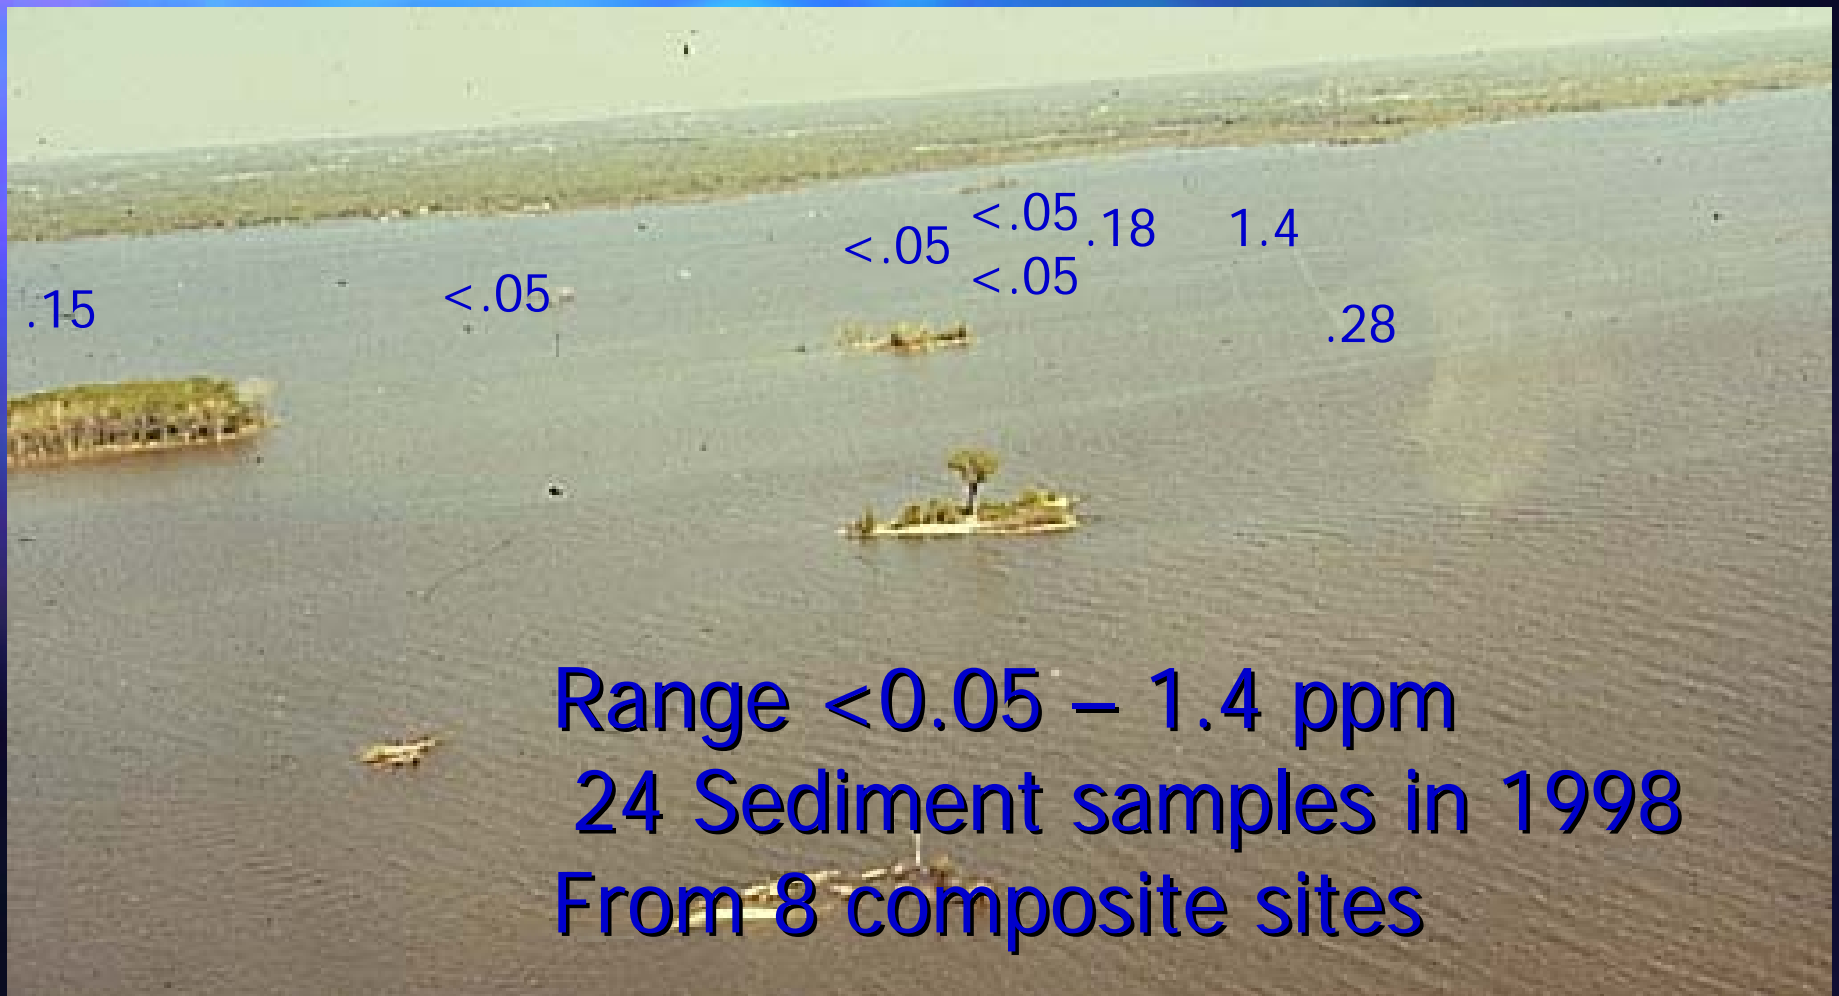
- Use cleanest dredged materials from outer channel to rebuild the Cat Island chain (higher in sands and lower in contaminants)
- Total PCBs should not exceed background (max of 0.1 ppm), 2.5 times less than Fox River cleanup goal

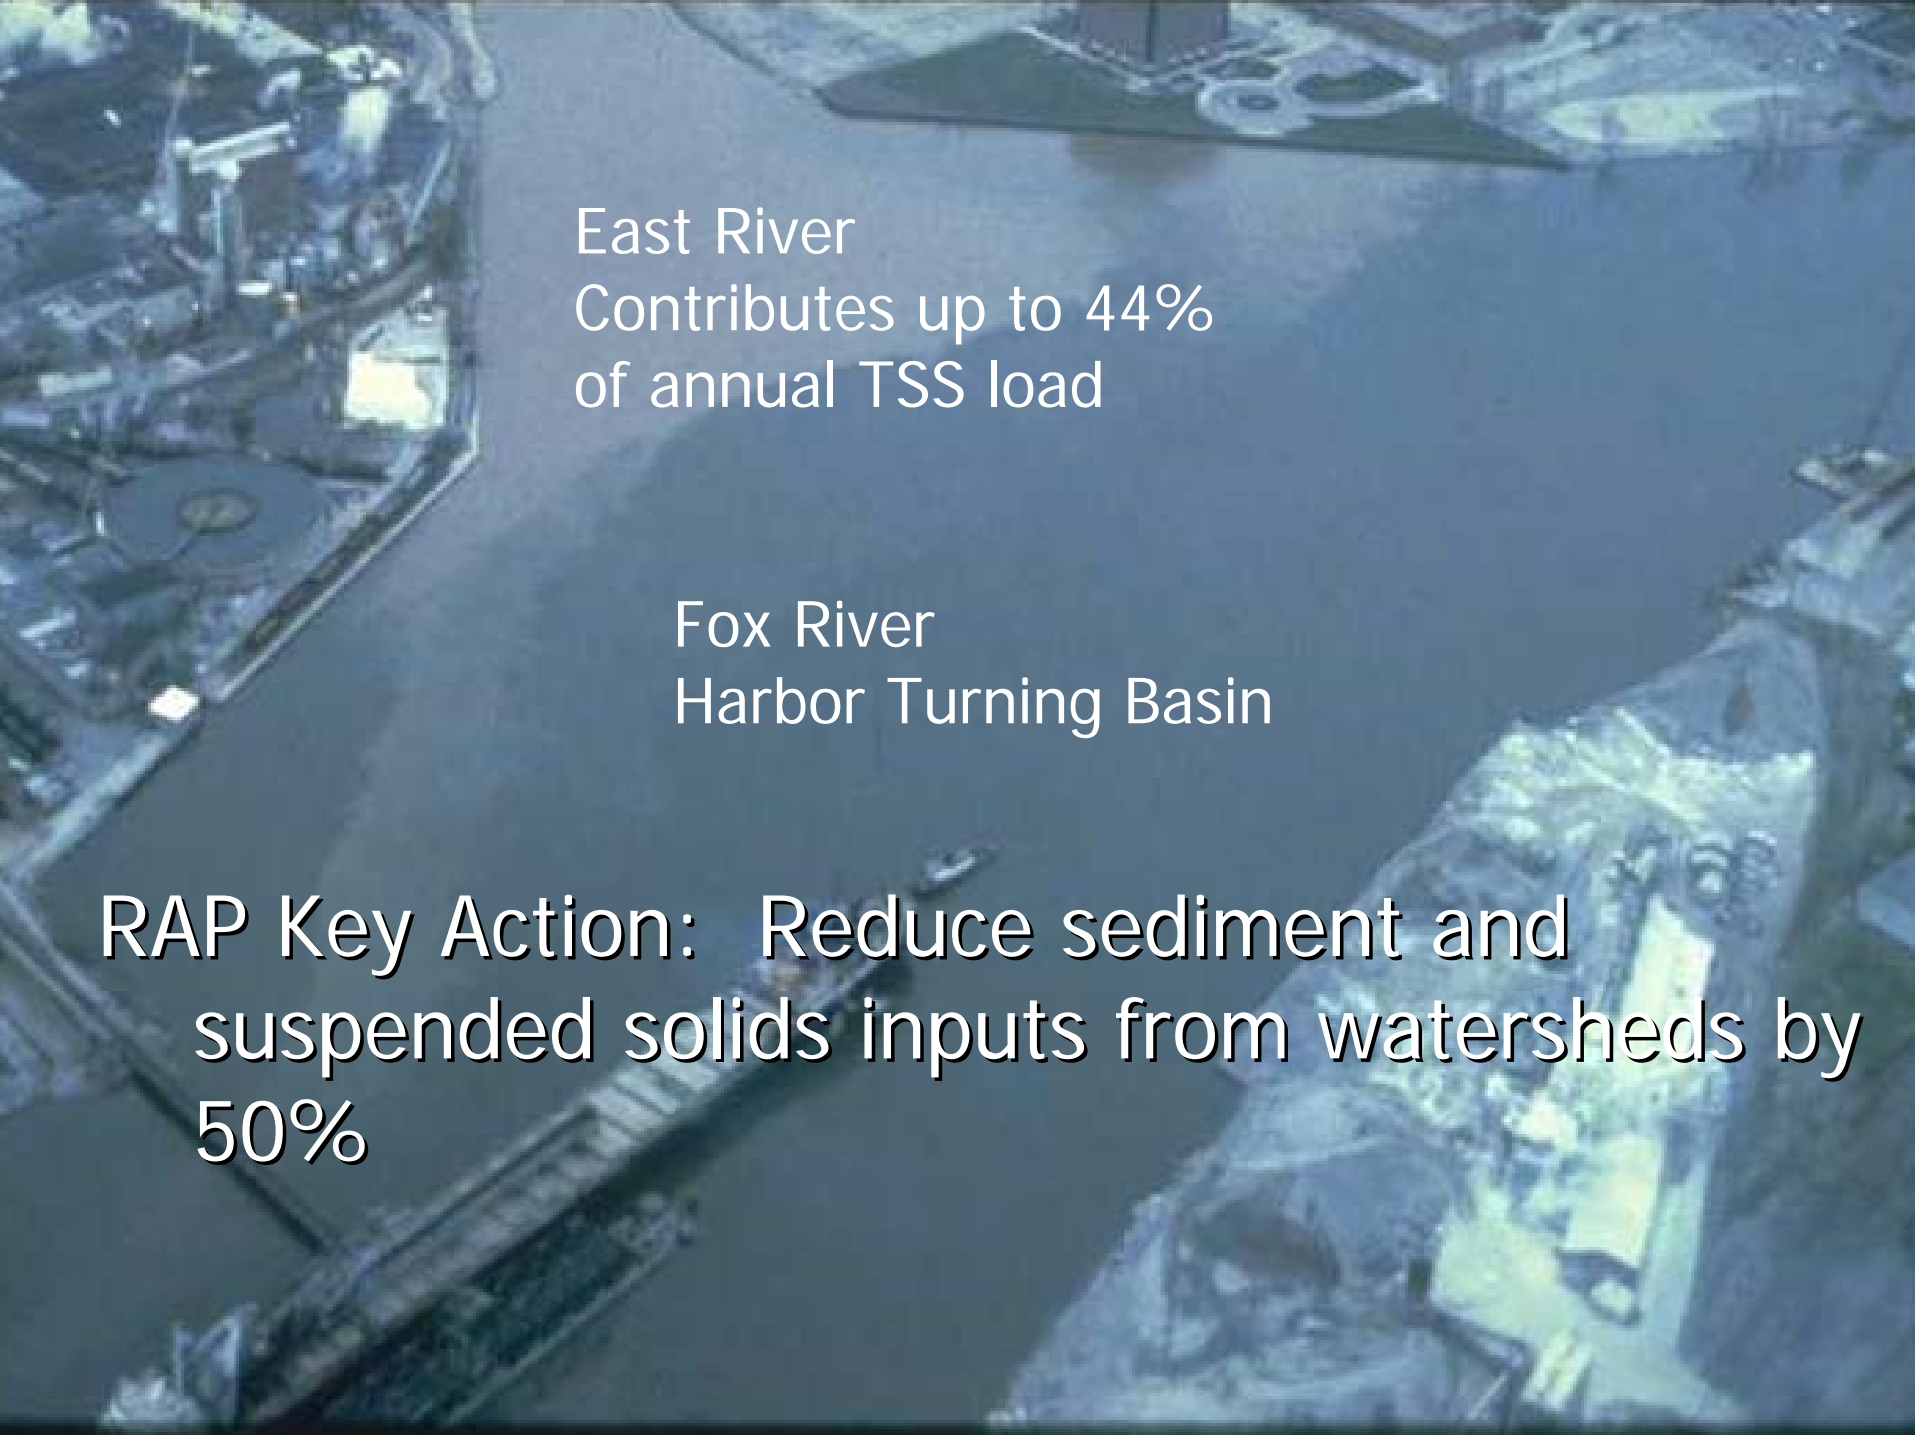
An aerial photograph of a harbor area. On the left, there are several large industrial buildings with complex roof structures. In the center, a large, dark, rectangular basin is visible, likely a turning basin. The water is a dark blue-grey color. The overall scene is industrial and urban.

East River
Contributes up to 44%
of annual TSS load
