UNIVERSITY OF WISCONSIN SEA GRANT INSTITUTE

## The Problem

Updated July 2015 WISCU-G-05-008

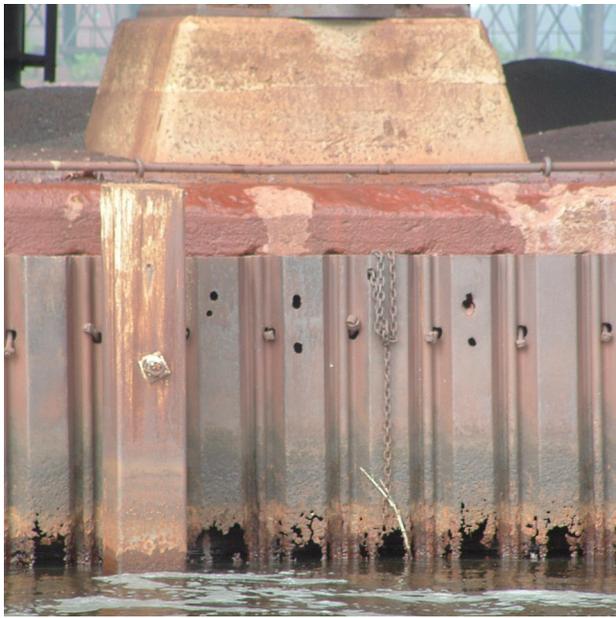
Widespread corrosion at Hancock, Michigan, (above) and Canadian National docks, Duluth, Minnesota (below)

Underwater inspections have revealed the corrosion is widespread throughout the Duluth-Superior Harbor on all types of steel piling. Most of the steel is covered with small pits, scooped out in diameters of  $\frac{1}{4}$  to 1 inch, primarily in the first 3 to 6 feet below the waterline and tapering off around 10 feet. For most structures there is only minor or insignificant corrosion loss deeper than 10 feet, all the way down to the mud line. Some of the steel dock structures have holes as large as 6 to 12 inches or more, and several of these structures have already been or are in the process of being repaired or replaced.

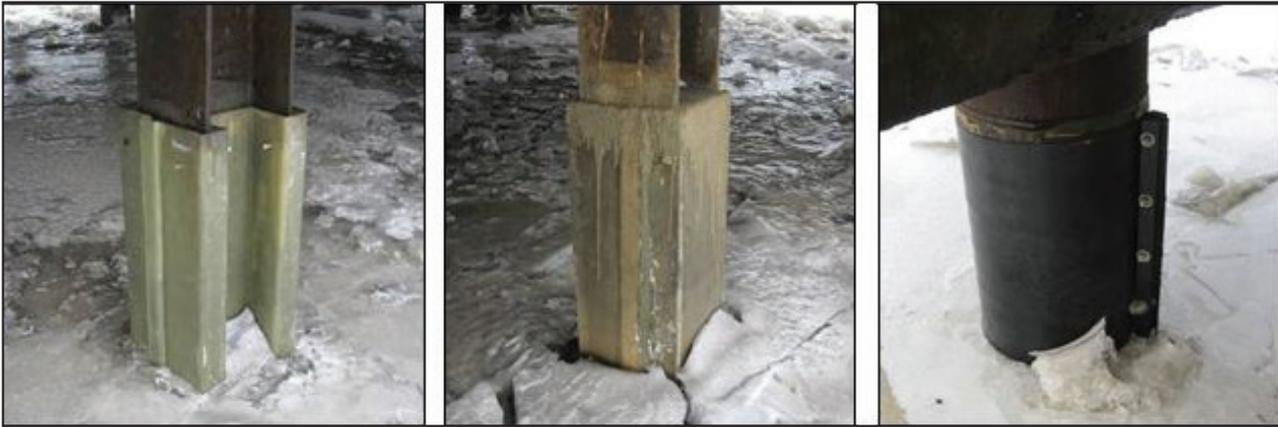
Pile test protection methods

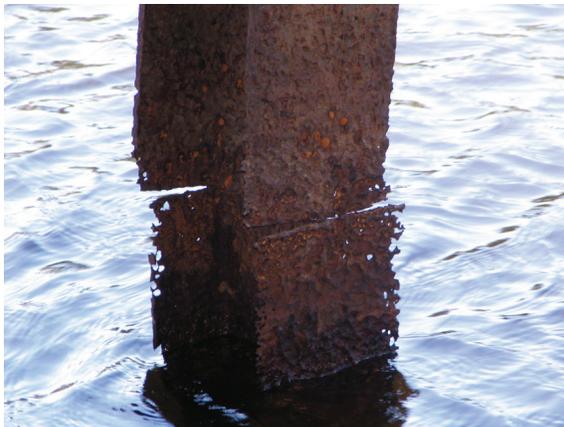
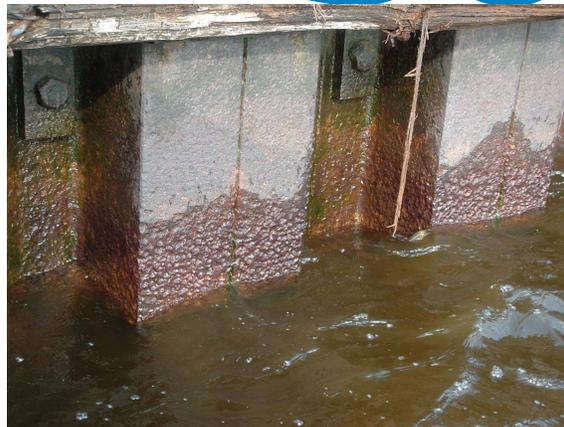
Steel H-pile corroded completely through (left) and Murphy oil dock (right)
