# **High Voltage Direct Current (HVDC) Interference Determination for Duluth Superior Harbor**

**Final Report Ver. 8.0**

**James B. Bushman, P.E., C.P.S., S.C.T. and Dr. Bopinder S. Phull, C.S.  
Bushman & Associates  
6395 Kennard Road  
Medina, OH 44256**

**December, 2008**

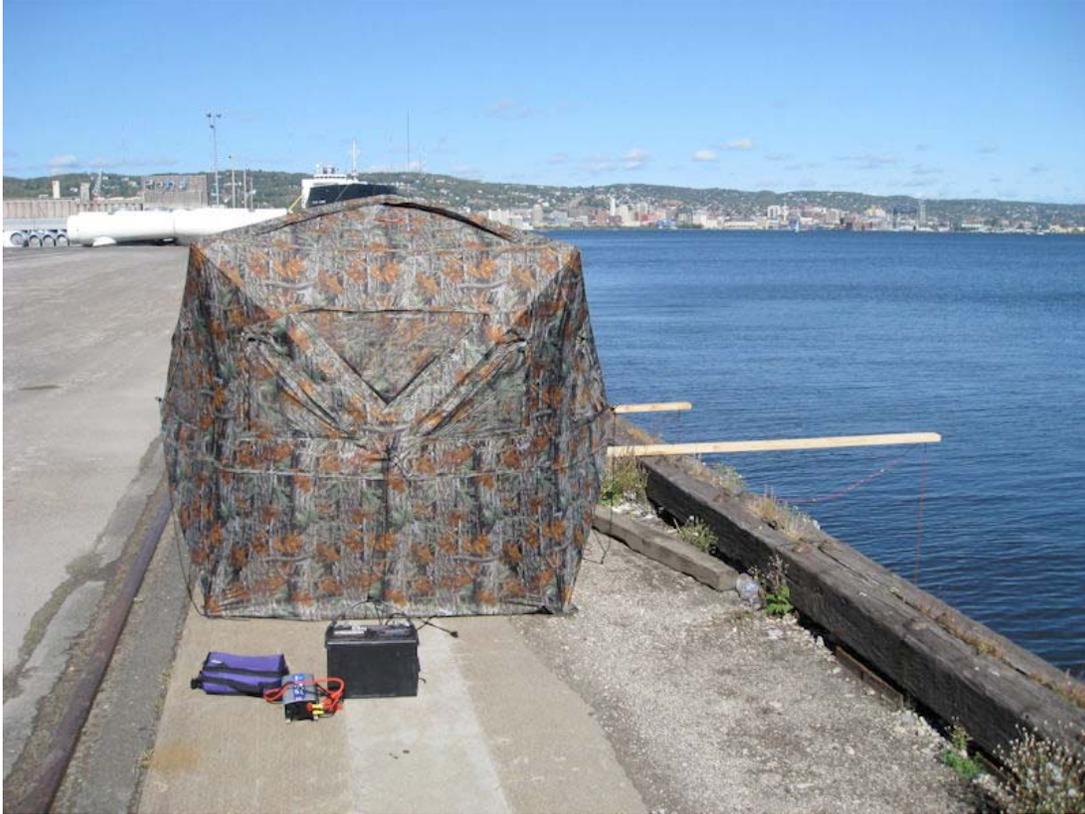
**Test Setup with Tent at Port Authority Test Site Terminal**

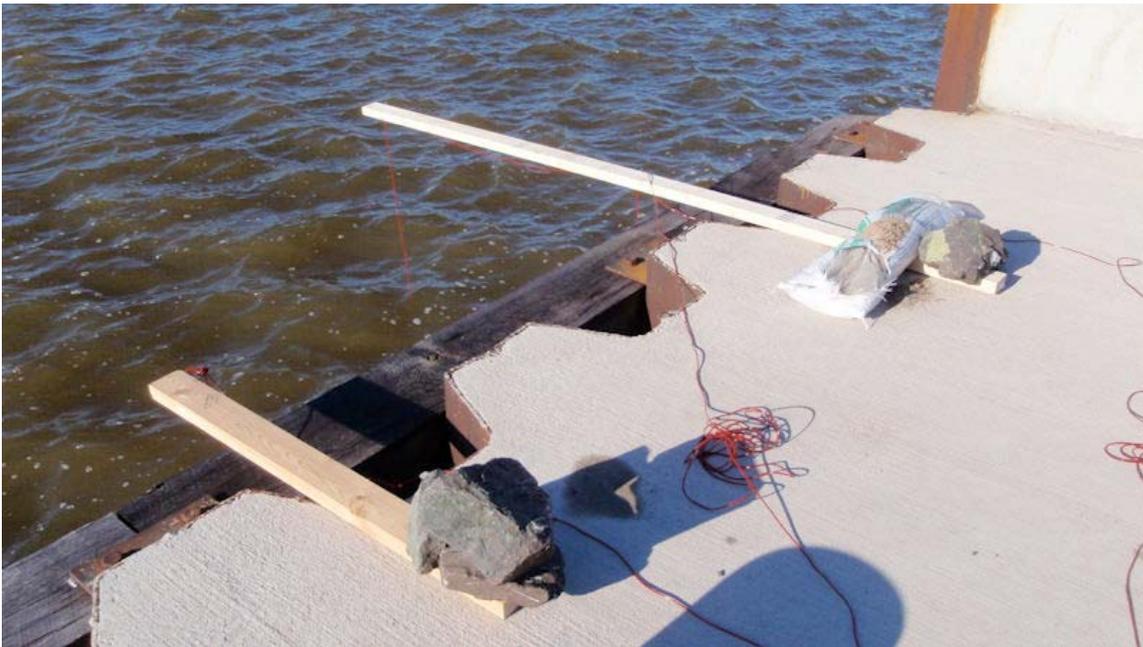
**Superior Entry Reference Cell Array**
