# Cofferdam Applied Coating Trial

Prepared for the City of Superior, Wisconsin

## Cofferdam Applied Coating Trial AMI Project 081127

Prepared for the City of Superior, Wisconsin  
October 20, 2009

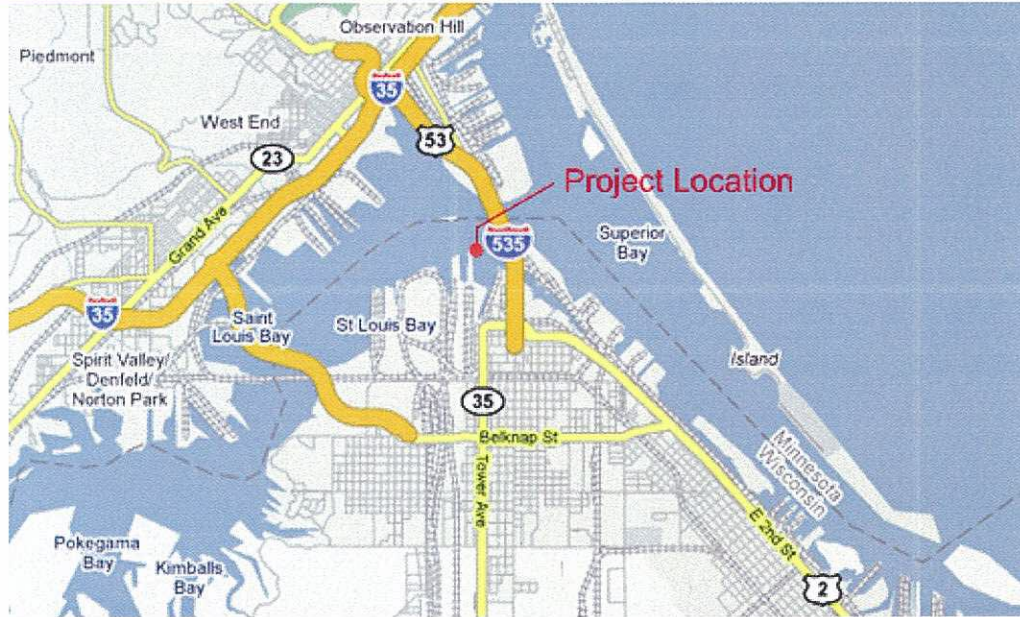
Picture 1: The location of the coating trial at the end of the Cenex Harvest States dock.

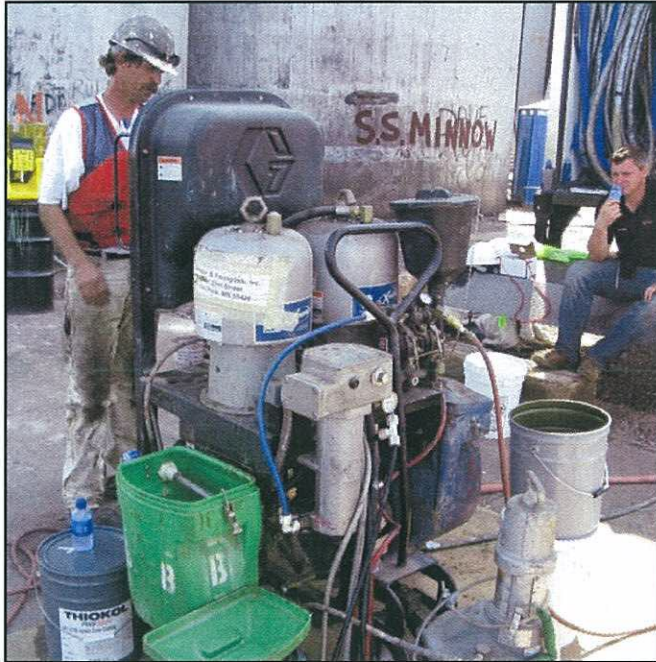
The airless sprayer was the simplest system and took the least amount of time to set up and clean. The Graco Xtreme Mix pump experienced several problems with its mix valve and also took a considerable amount of time to start up after a new product was put into it. The Graco Reactor pump worked well during the trial but experienced one problem at the beginning of an application that led to a lengthy clean up of the wall before the work could continue. The pump supplied by Ecologiq appeared to work without any problems. No preheating was required and the metering was mechanically built into the pump resulting in a simple system not susceptible to problems.

**Picture 4: The Graco Xtreme Mix Pump being prepared for an application.**
