## FINDING SOLUTIONS TO A MYSTERIOUS HARBOR CORROSION PROBLEM

*Gene Clark and Kathleen Schmitt Kline*

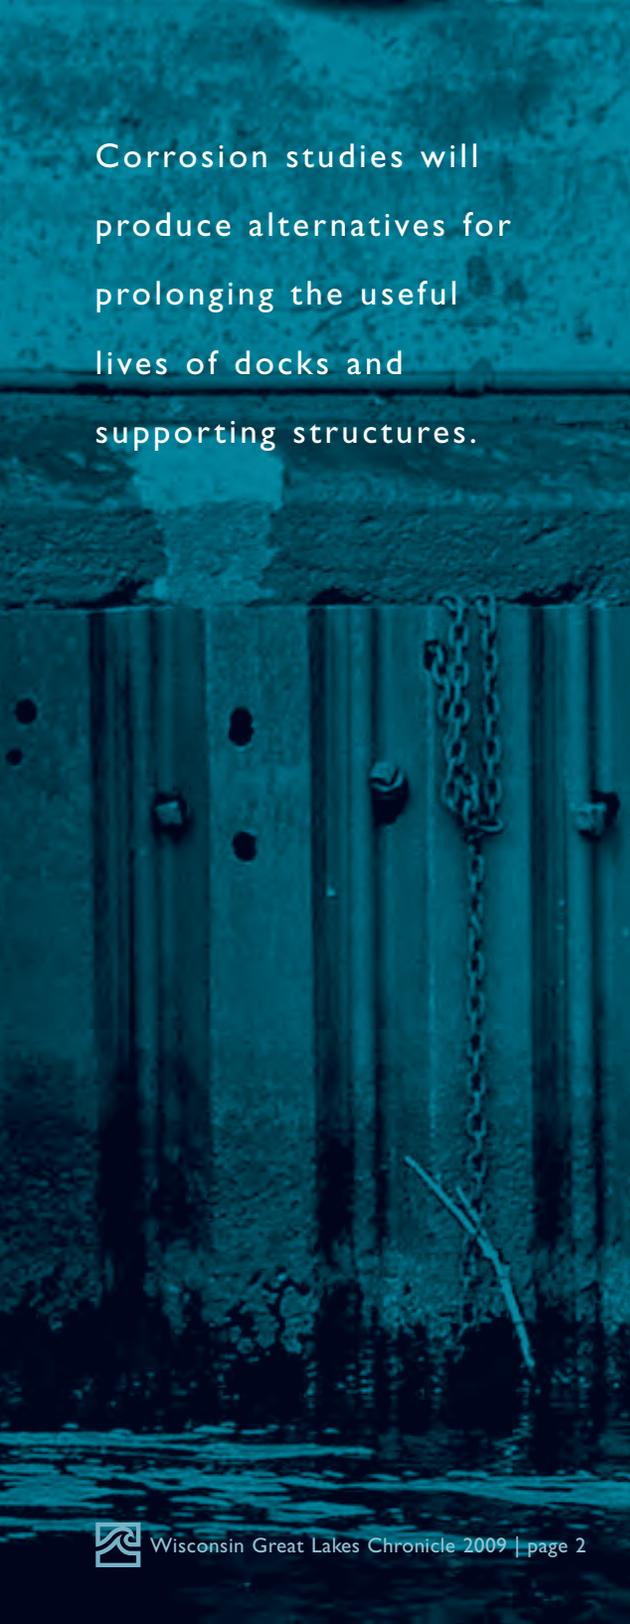
Corrosion studies will produce alternatives for prolonging the useful lives of docks and supporting structures.
