DSPA CORROSION INVESTIGATION REPORT

AMI #061016 DATE: JULY to DECEMBER, 2006

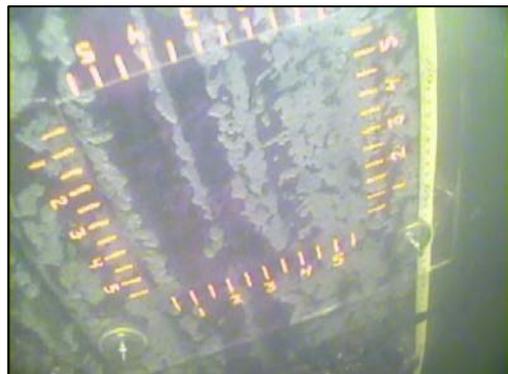
0 to 0.5 feet below IGLD

Generally the full material thickness remains with a lower severity of pitting.

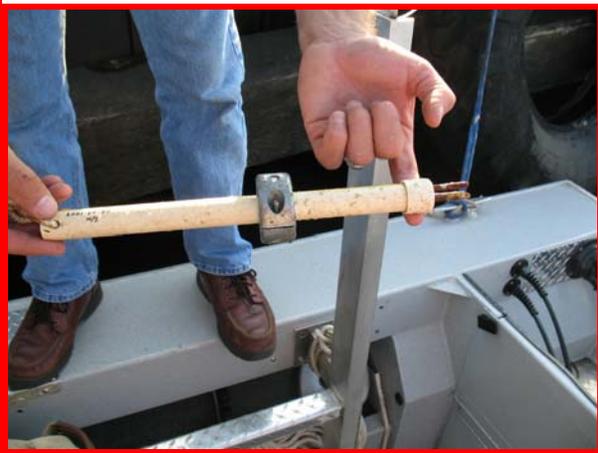
Figure 3 - LPR Probe after 1 week exposure

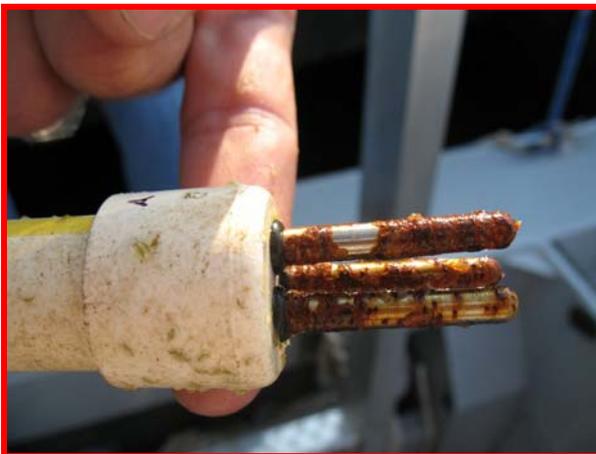
Figure 4 - LPR Test Probe Tips after 2 weeks exposure
